# Flooding in Dawson: Exposure analysis and risk reduction recommendations

March | 2022

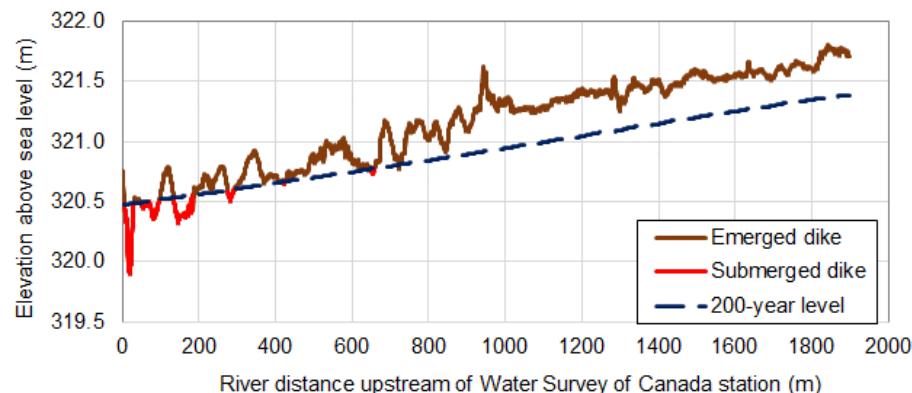
For a 200-year event simulation, it is obvious that water could enter town over the dike on several low points at the downstream end of town. This represents the dominant flooding factor over the status of the storm drain valves and manhole elevations. The water surface elevation at the location where water would flow over the dike (middle of the 4 low points identified in Figure 4.1.1) is 320.6 m. For the simulation, upstream and downstream areas in town were filled up to this level, assuming that the flood event would last long-enough to reach an equilibrium hydraulic condition, with largely stagnant water in Dawson (like in 1979).

**FIGURE 4.1.1 PROFILE OF THE 200-YEAR WATER SURFACE (RIVER SIDE) AND SURFACE ELEVATION OF THE DIKE. LOW POINTS THAT WOULD ALLOW WATER TO FLOOD DOWNTOWN ARE DEPICTED IN RED.**

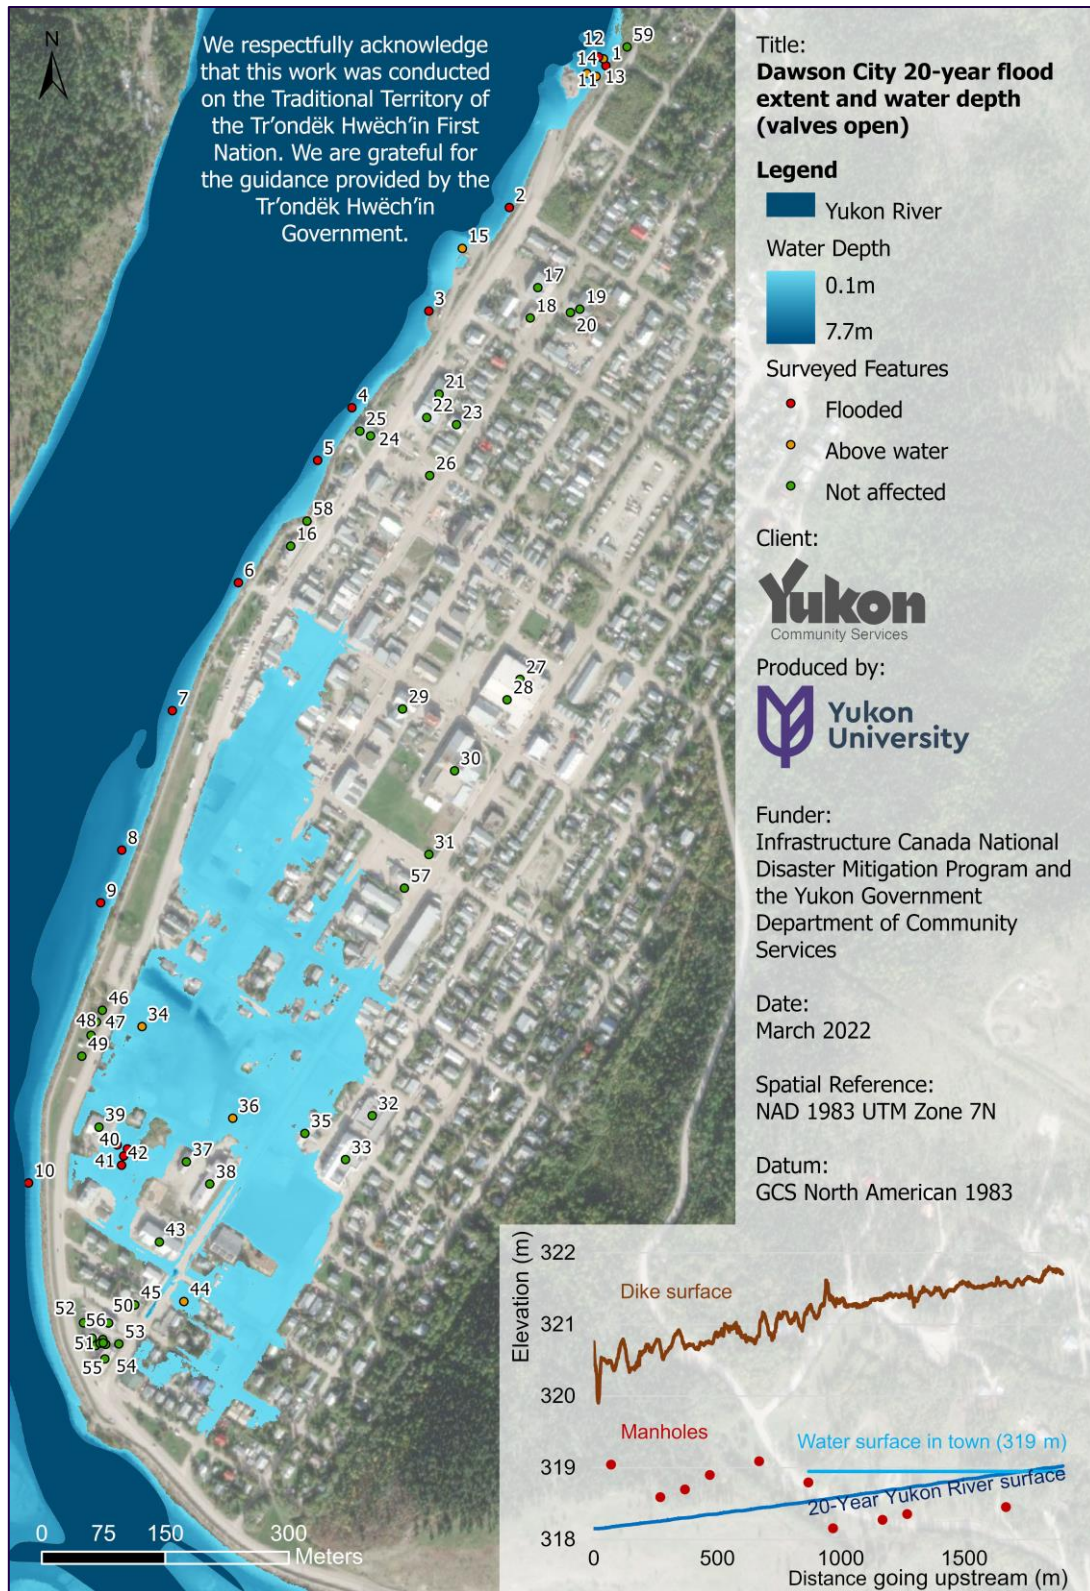
**FIGURE 4.2.4. 20-YEAR FLOOD EXTENT (WITH OPEN STORM DRAINS AND MANHOLES), WATER DEPTH, AND SURVEYED ASSETS CATEGORIZED BY FLOOD EXPOSURE. SOME FLOOD DAMAGE TO REPORT.**

For a 20-year flood event, water could enter the dike perimeter through storm drains and flood a portion of the downtown area (Figure 4.2.4). For slightly higher water levels in the Yukon River, a larger portion of the downtown area would be flooded. Section 6 presents mitigation measures that could be used to prevent water infiltration in Dawson for the 20-year flood scenario (and the flood extent would therefore correspond to what is presented in Figure 4.2.3, with no damage).

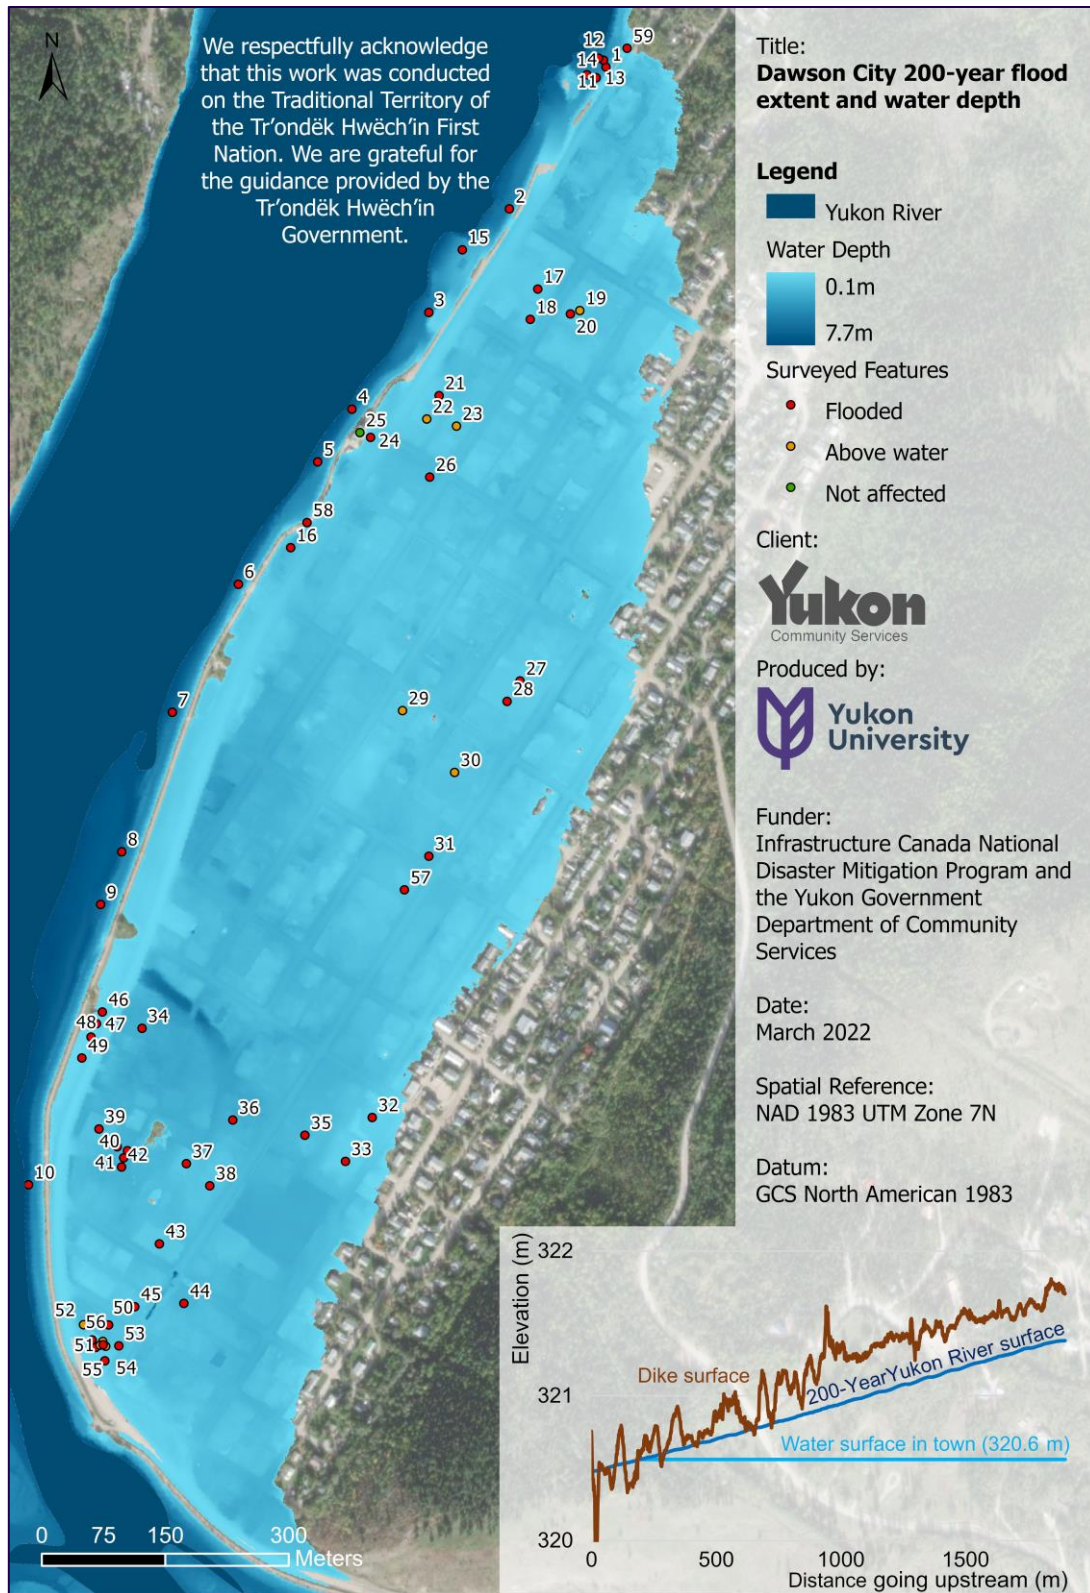
**FIGURE 4.2.5. 200-YEAR FLOOD EXTENT, WATER DEPTH, AND SURVEYED ASSETS CATEGORIZED BY FLOOD EXPOSURE. EXTREME FLOOD DAMAGE TO REPORT.**

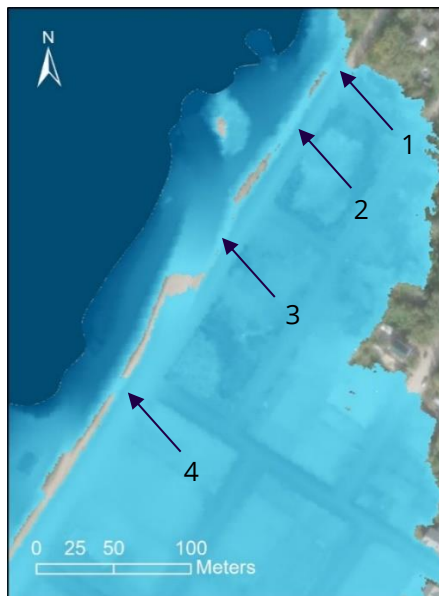
**FIGURE 4.2.6. FOUR LOW SEGMENTS OF THE DIKE ON THE NORTH SIDE OF DAWSON WHERE A 200-YEAR HYDROLOGICAL EVENT GENERATES A FLOOD IN DOWNTOWN DAWSON.**

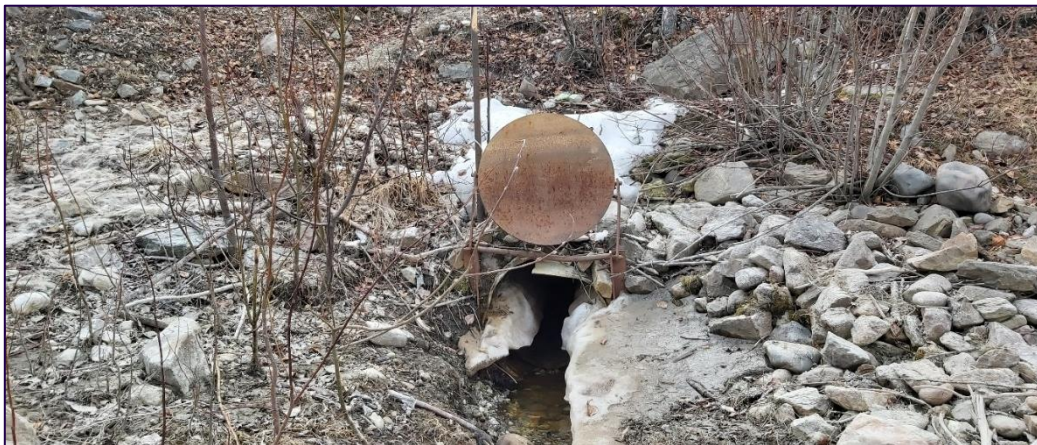
**FIGURE 6.2.1. STORM DRAIN OUTLET AND VALVE OBSTRUCTED BY ICE AND DEBRIS (QUEEN STREET DRAIN).**

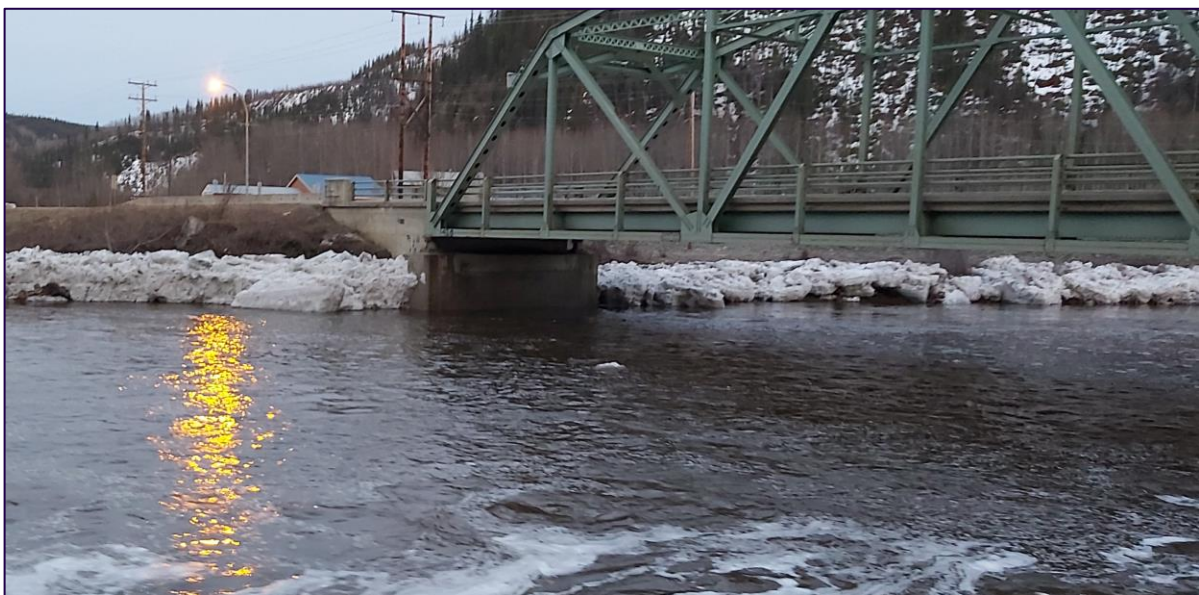
**FIGURE 6.8.1. INTERFERENCE OF THE KLONDIKE HIGHWAY BRIDGE ABUTMENT DURING 2021 BREAKUP (LEFT BANK, UPSTREAM SIDE). ICE FLOES COULD ALMOST REACH THE LOWER PART OF THE BRIDGE STRUCTURE AT BREAKUP DESPITE AN ONLY MODERATE INTENSITY EVENT.**

- Perform an engineering investigation of ice-jam flood hazards at the bridge.
- Independently of the official ice jam risk to the bridge integrity, consider one or multiple mitigation options:
  - Providing access to machinery that would break the toe of an ice jam from the banks, downstream of the bridge (along C-4 subdivision).
  - Designing water evacuation structures downstream of the Klondike Highway bridge at an elevation that would protect the bridge structure
  - Lowering the eastern approach of the Klondike Highway to the bridge (possibly an erosion-triggered controlled failure mode) in order to provide excess-water evacuation capacity around a major ice jam (in the order of 200 m<sup>3</sup>/s).

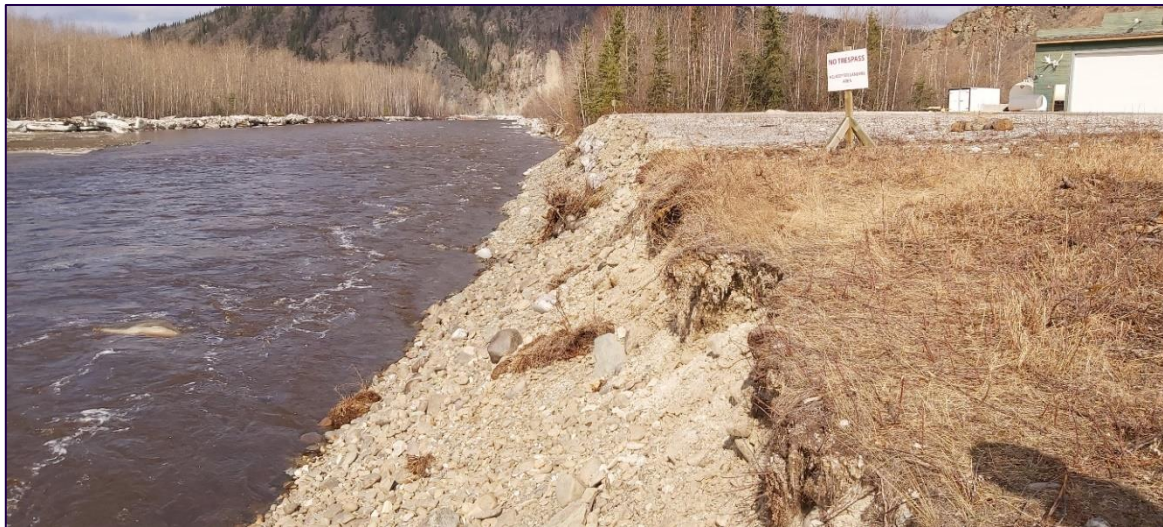
**FIGURE 6.9.1. ERODIBLE BANK IN THE KLONDIKE RIVER AT TRANS NORTH HELICOPTERS JUST DOWNSTREAM OF A BEND.**

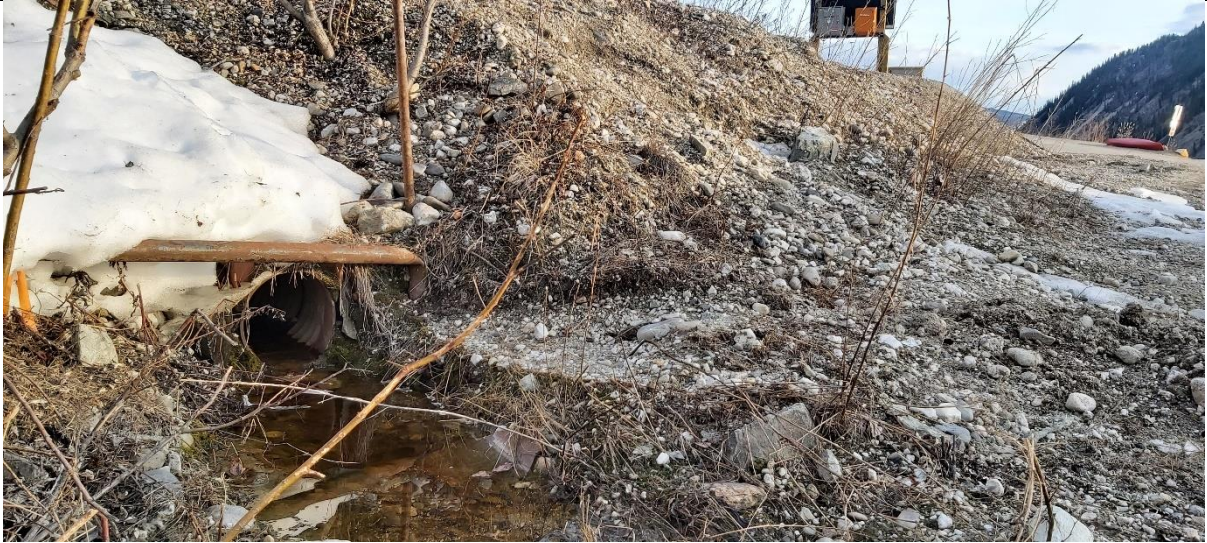
Surveyed feature	Top of drain (no valve)		
Elevation	317.2 m	Flood return period	(river side of dike) 5 years
Note: Elevation of lowest manhole connected to this drain is 319.0 m		Annual flood probability	(river side of dike) 20%

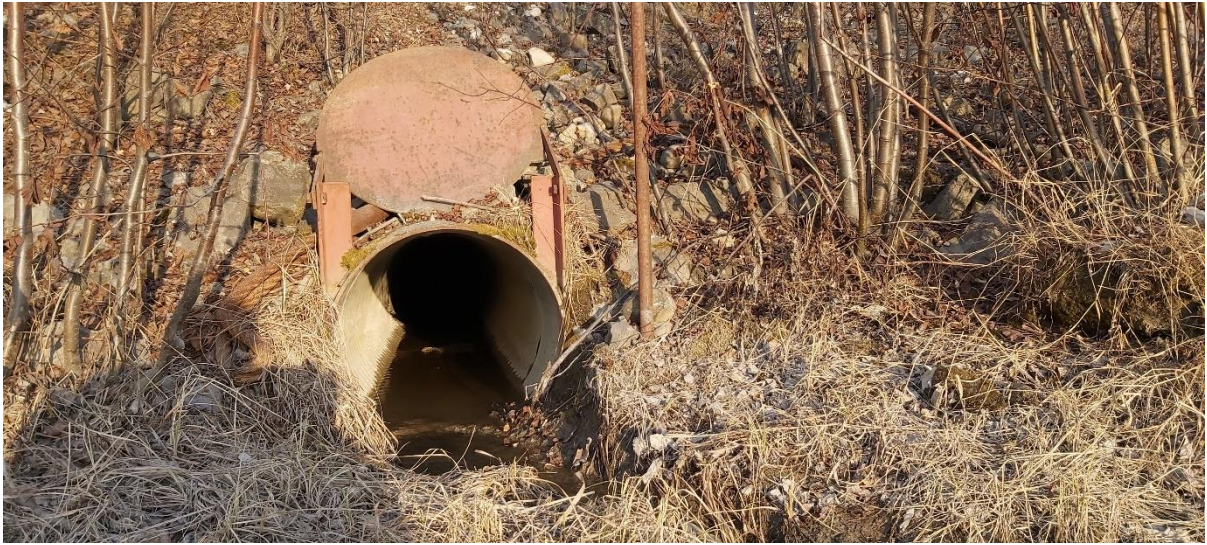
Community	Dawson		
ID #	2		
Asset	Storm Drain Albert St.		
Location	River side of dike, aligned with Albert St.

Surveyed feature	Top of drain		
Elevation	316.5 m	Flood return period	(river side of dike) 2 years
Note: Elevation of lowest manhole connected to this drain is 318.6 m		Annual flood probability	(river side of dike) 55%

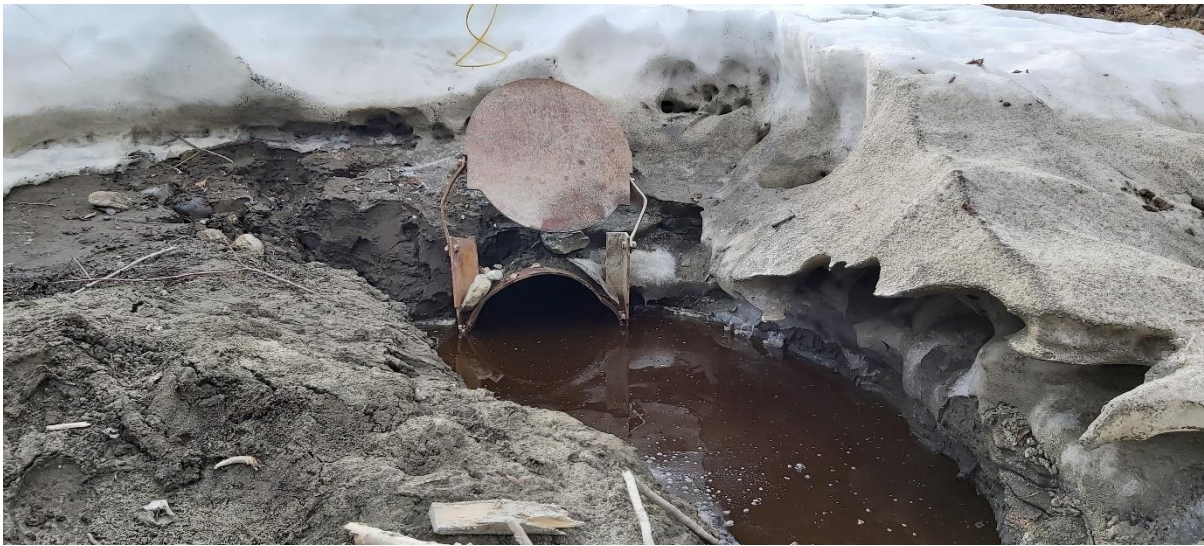
Surveyed feature	Top of drain			
Elevation	314.8 m	Flood return period	(river side of dike)	0.1 years
Note: Elevation of lowest manhole connected to this drain is 318.2 m (lowest drain outlet in Dawson connected to the probably lowest manhole in Dawson)		Annual flood probability	(river side of dike)	800 %
