# Flooding in Dawson: Exposure analysis and risk reduction recommendations

March | 2022

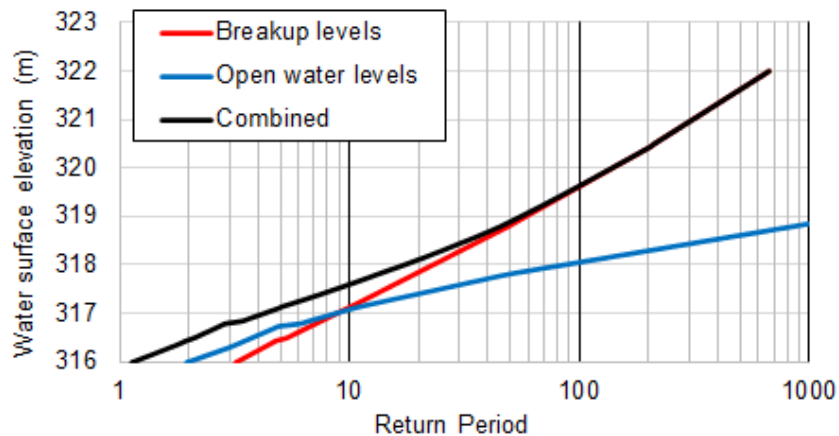
Based on data from recent years at hydrometric station 09EB001 (Yukon River at Dawson) operated by the Water Survey of Canada (WSC), it seems that the highest water level on an annual basis is most often caused by open water conditions. However, as Figure 3.1.1 reveals, ice jams are more likely to be associated with the most extreme events (Turcotte, 2021). As a result, ice jam water levels should be used for engineering design and emergency response planning.

**FIGURE 3.1.1. RELATIONSHIP BETWEEN THE WATER SURFACE ELEVATION AND THE RETURN PERIOD OF BREAKUP AND OPEN WATER EVENTS (AS WELL AS COMBINED STATISTICS) AT STATION 09EB001 LOCATED DOWNSTREAM OF DAWSON.**

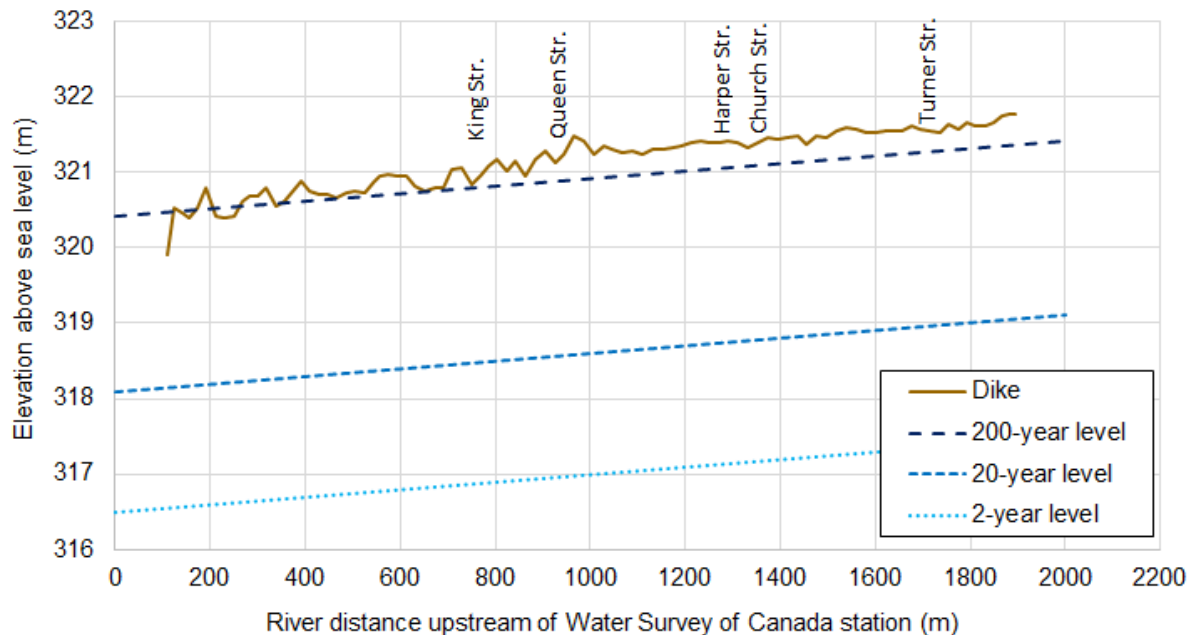
**FIGURE 3.3.1 WATER SURFACE PROFILE OF THE YUKON RIVER AT DAWSON FOR 2-YEAR, 20-YEAR, AND 200-YEAR HYDROLOGICAL EVENTS, INCLUDING THE SURFACE OF THE DIKE.**

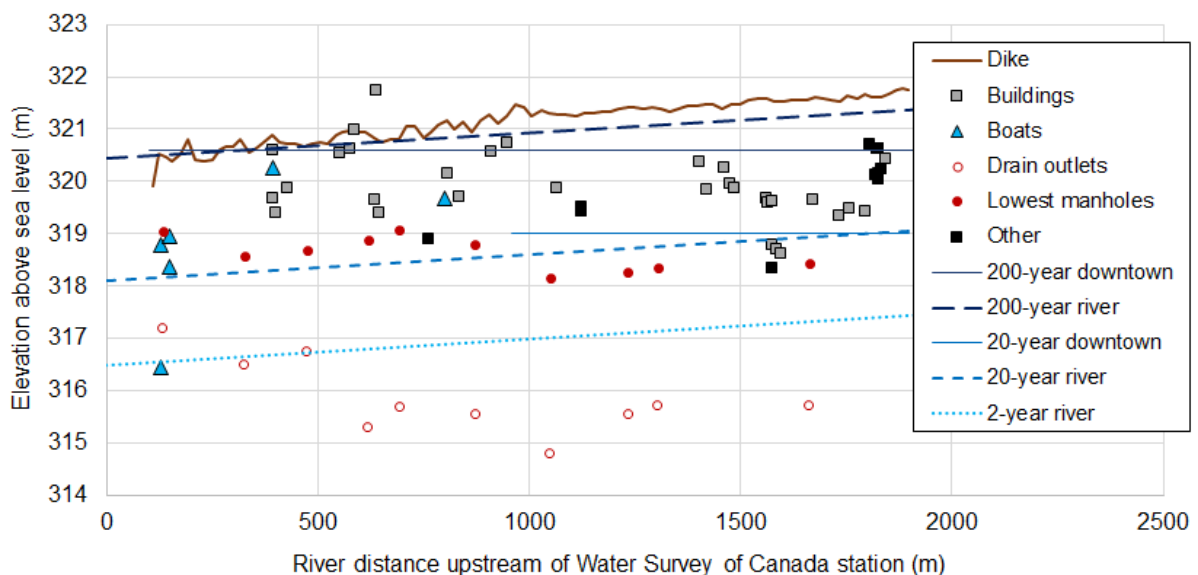
Figure 4.2.1 presents the lateral (from the river looking through town) view of the high-water event profiles including surveyed assets. It shows, for example, that drain outlets are regularly underwater, preventing access to the valves that should be closed manually to prevent backwater flooding in Dawson. On the other hand, very few buildings and assets would be affected by a backwater flood more frequently than once every 20 years, on average.

**FIGURE 4.2.1. SURVEYED ASSETS, WATER SURFACE PROFILES OF THE YUKON RIVER AT DAWSON FOR 2-YEAR, 20-YEAR, AND 200-YEAR HYDROLOGICAL EVENTS, AND WATER SURFACE ELEVATION ASSOCIATED WITH A STORM DRAIN BACKWATER FOR CORRESPONDING EVENTS.**

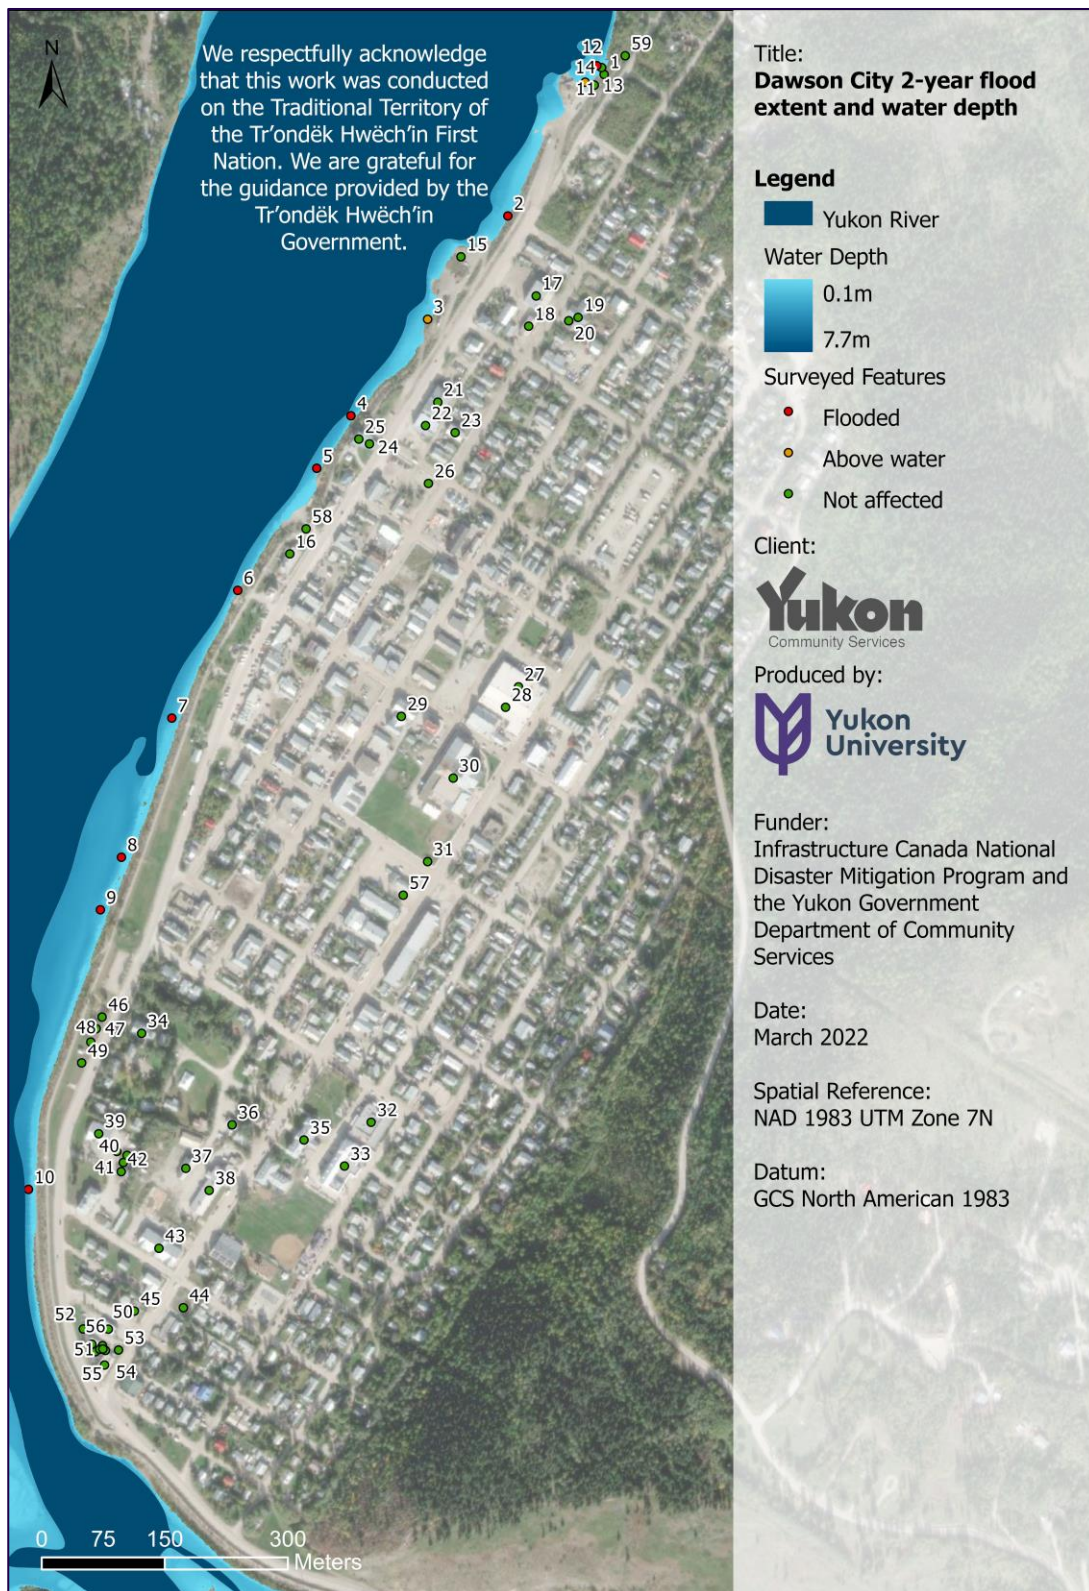
**FIGURE 4.2.2. 2-YEAR FLOOD EXTENT, WATER DEPTH, AND SURVEYED ASSETS CATEGORIZED BY FLOOD EXPOSURE. NO FLOOD DAMAGE TO REPORT.**

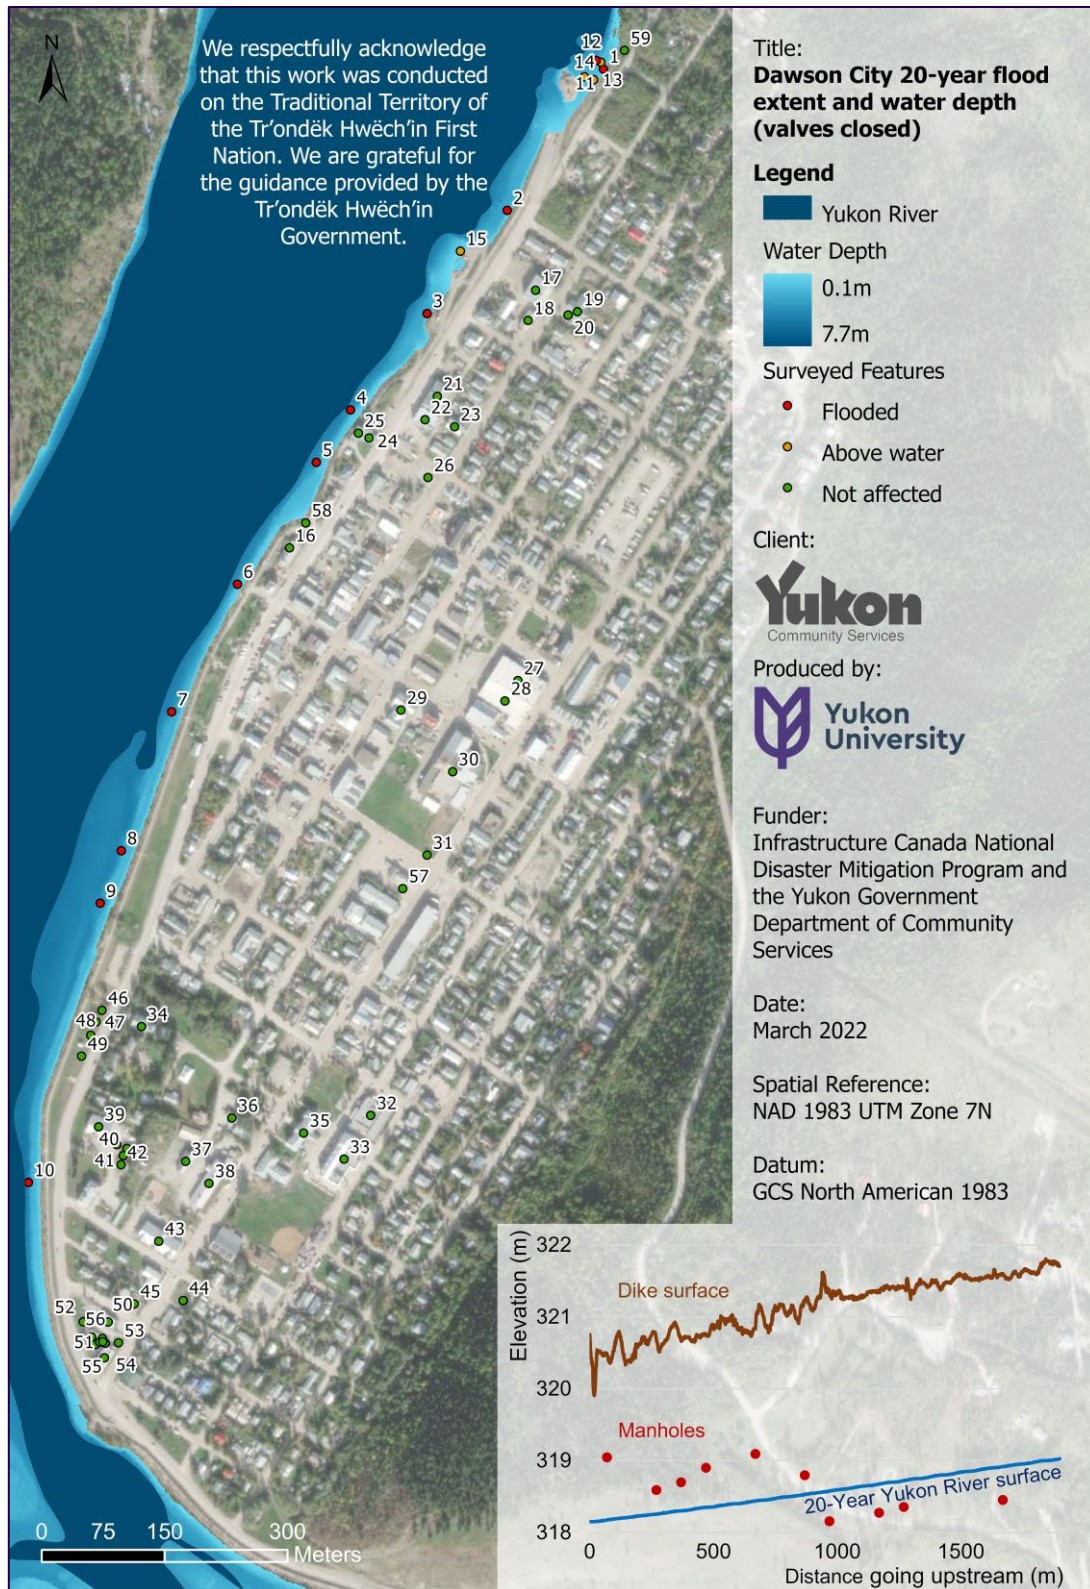
**FIGURE 4.2.3. 20-YEAR FLOOD EXTENT (WITH STORM DRAIN VALVES OR MANHOLES CLOSED), WATER DEPTH, AND SURVEYED ASSETS CATEGORIZED BY FLOOD EXPOSURE. NO FLOOD DAMAGE TO REPORT.**

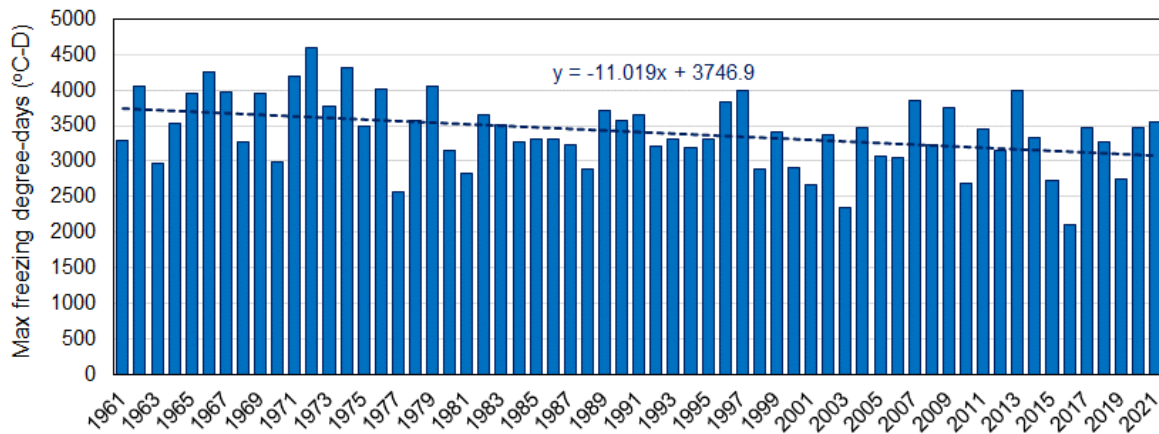
In terms of high ice cover strength, high resistance could be achieved through a cold winter (the ice cover becomes very thick by thermal condition, or because of heat loss) or through a very dynamic freeze-up. On one hand, Figure 5.2.1 presents the maximum freezing degree-days at Dawson since 1961 and clearly shows that extremely cold winters seemed to become less frequent (each winter, a day at -11°C is replaced by a day at 0°C). This aligns with declining measured ice cover thicknesses by the WSC on the Yukon River upstream of the White River outlet since 2006 (admittedly a short record). On the other hand, flows in the fall are apparently becoming more significant (Figure 5.2.2), which might cause more frequent dynamic ice cover formations (like in the fall of 2020), at least at specific locations.

**FIGURE 5.2.1. MAXIMUM FREEZING DEGREE-DAYS AT DAWSON SINCE 1961. THE TREND IS DECREASING, WITH A VARIABILITY THAT REMAINING HIGH.**

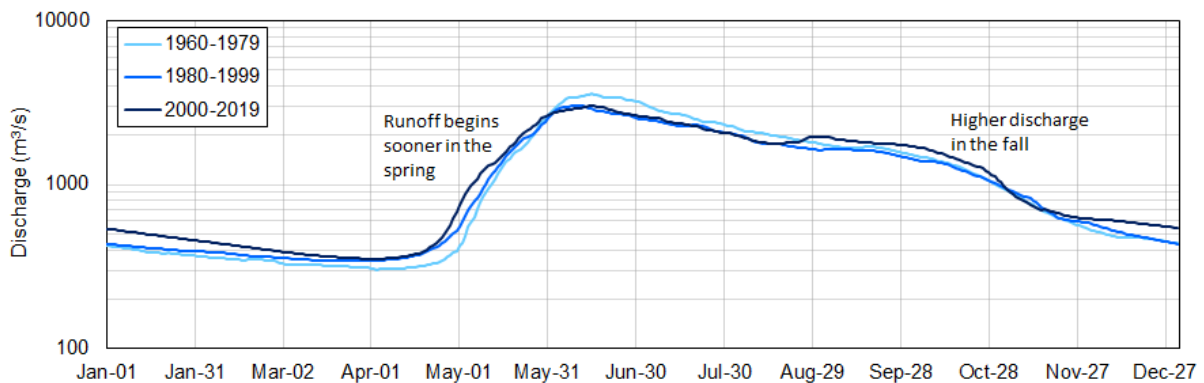
**FIGURE 5.2.2. DAILY-AVERAGED DISCHARGE FROM THE YUKON RIVER UPSTREAM OF WHITE RIVER FOR THREE PERIODS OF 20 YEARS. THE 2000-2019 PERIOD SEEMS TO PRESENT HIGHER DISCHARGE VALUES IN THE SPRING AND FALL.**

In terms of breakup driving force mostly dictated by runoff rates, more extreme precipitation (and snowpack) and air temperature conditions seem conducive for a weather sequence that would generate a higher discharge sooner in the spring (as suggested by Figure 5.2.2). However, more instability in spring air temperatures, with warm conditions intercepted by colder air masses, may break the momentum of runoff waves in large watersheds more often than in the past, therefore attenuating the rate of rise in spring flow (the Yukon River needs a strong multi-day warm temperature anomaly to generate consistent high runoff). Permafrost thaw does not seem to play a significant role in spring snowmelt since the ground is mostly frozen at the end of winter. The impact of forest fires on snowmelt and runoff rates is also complex: snow sublimation will increase, therefore reducing the snow water equivalent, but snowmelt rates could increase as the snowpack in entire sub watersheds would be exposed to short wave radiation.

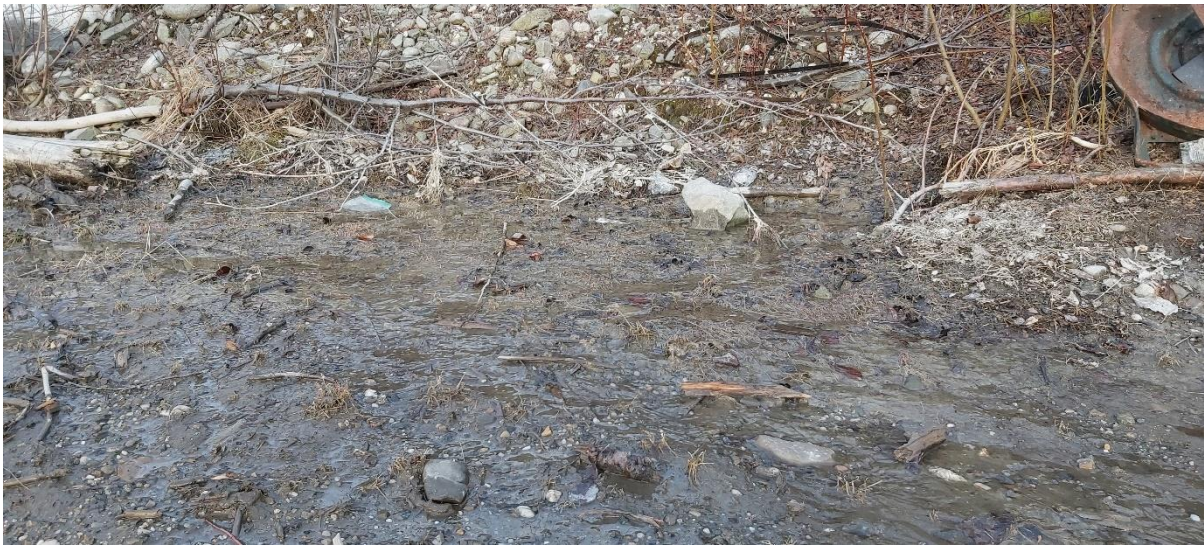
Community	Dawson			
ID #	3			
Asset	Storm Drain Duke St.			
Location	River side of dike, aligned with Duke St. (buried when surveyed)

Note that Duke Street drain outlet was buried at the time of visit. This condition may lead to water accumulation in the street during snowmelt and intense rain events, and it should be addressed.

Surveyed feature	Ground level at approximate drain location (water flowing from ground)			
Elevation	316.8 m	Flood return period	(river side of dike)	2 years
Note: Elevation of lowest manhole connected to this drain is 318.7 m		Annual flood probability	(river side of dike)	50%

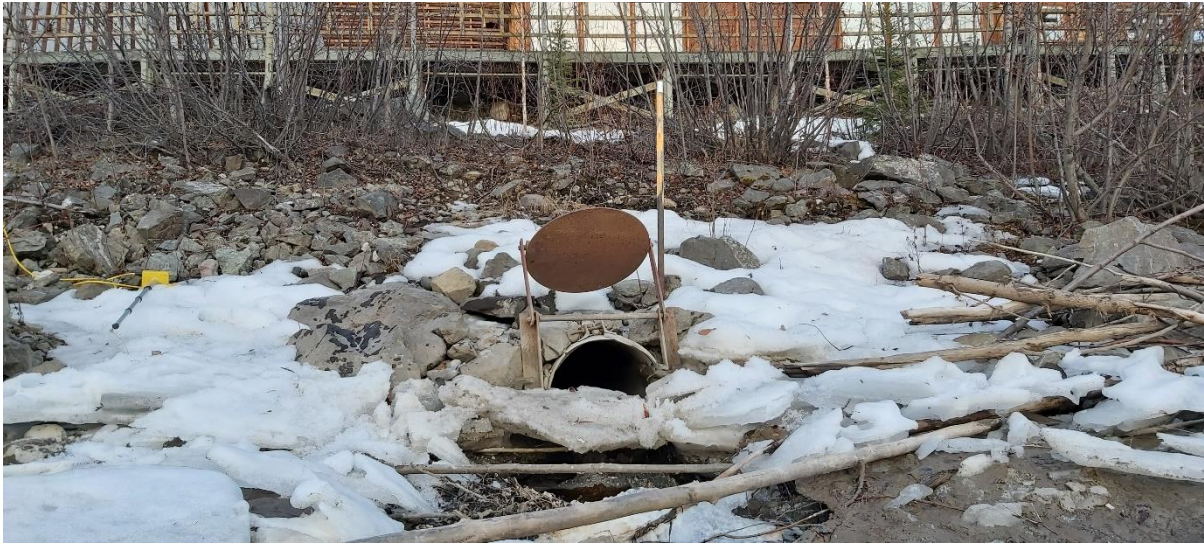
Community	Dawson		
ID #	4		
Asset	Storm Drain York St.		
Location	River side of dike, aligned with Duke St. (below Dänojà Zho Cultural Centre)

Surveyed feature	Top of drain		
Elevation	315.3 m	Flood return period	(river side of dike) 0.3 years
Note: Elevation of lowest manhole connected to this drain is 318.9 m		Annual flood probability	(river side of dike) 300 %

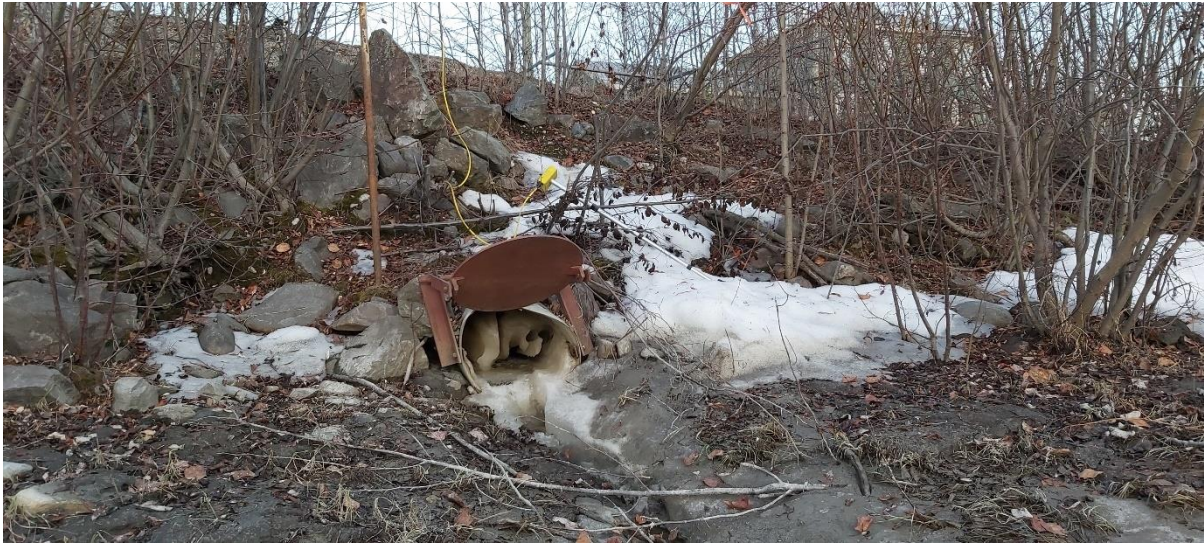
Community	Dawson		
ID #	5		
Asset	Storm Drain King St.		
Location	River side of dike, aligned with King St.

Surveyed feature	Top of drain		
Elevation	315.7 m	Flood return period	(river side of dike) 0.5 years
Note: Elevation of lowest manhole connected to this drain is 319.1m		Annual flood probability	(river side of dike) 220 %

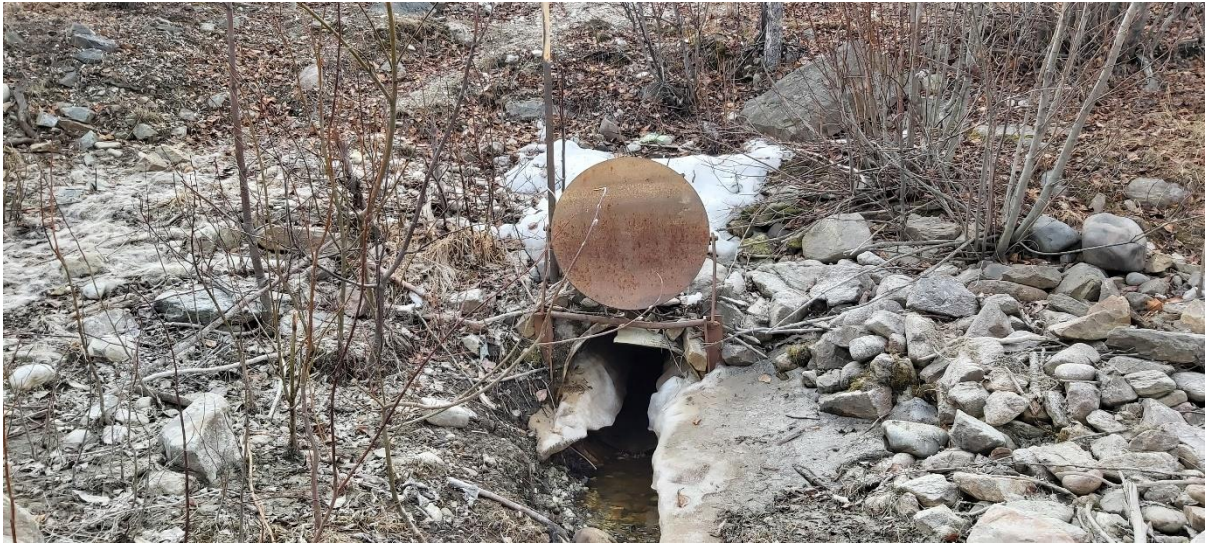
Community	Dawson		
ID #	6		
Asset	Storm Drain Queen St.		
Location	River side of dike, aligned with Queen St.

Surveyed feature	Top of drain		
Elevation	315.6 m	Flood return period	(river side of dike) 0.4 years
Note: Elevation of lowest manhole connected to this drain is 318.8 m		Annual flood probability	(river side of dike) 280 %

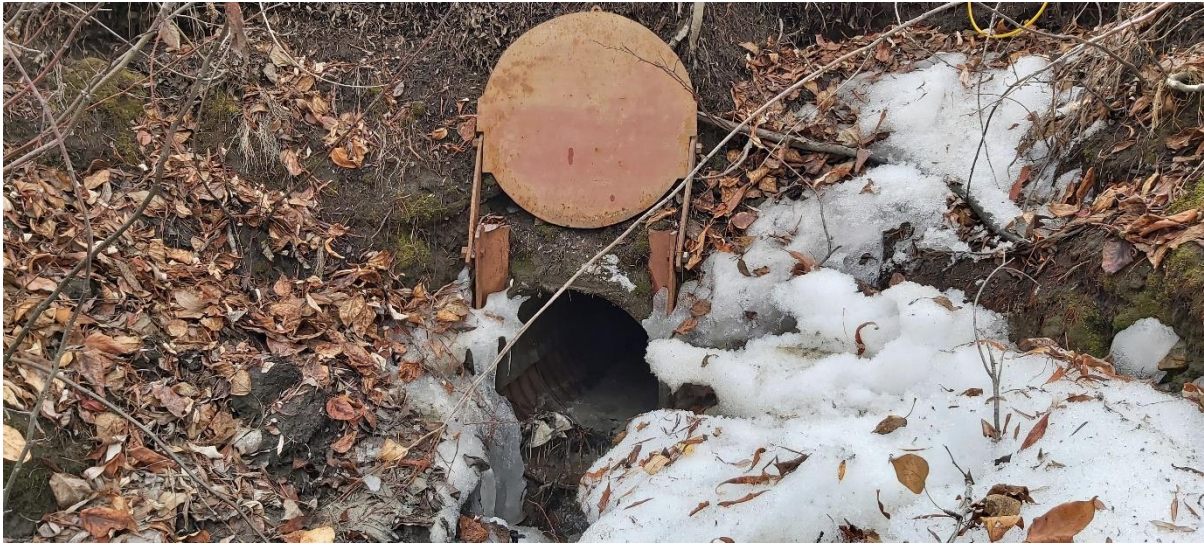
Community	Dawson		
ID #	8		
Asset	Storm Drain Harper St.		
Location	River side of dike, aligned with Harper St.

Surveyed feature	Top of drain		
Elevation	315.6 m	Flood return period	(river side of dike) 0.3 years
Note: Elevation of lowest manhole connected to this drain is 318.3 m		Annual flood probability	(river side of dike) 350 %

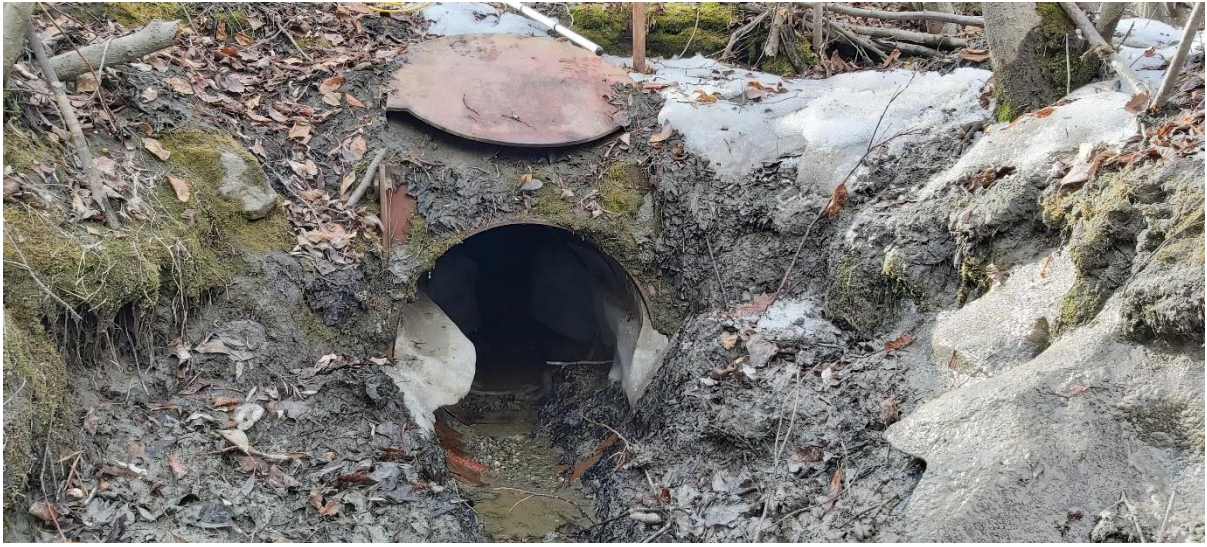
Community	Dawson		
ID #	9		
Asset	Storm Drain Church St.		
Location	River side of dike, aligned with Church St.

Surveyed feature	Top of drain		
Elevation	315.7 m	Flood return period	(river side of dike) 0.3 years
Note: Elevation of lowest manhole connected to this drain is 318.4 m		Annual flood probability	(river side of dike) 300 %

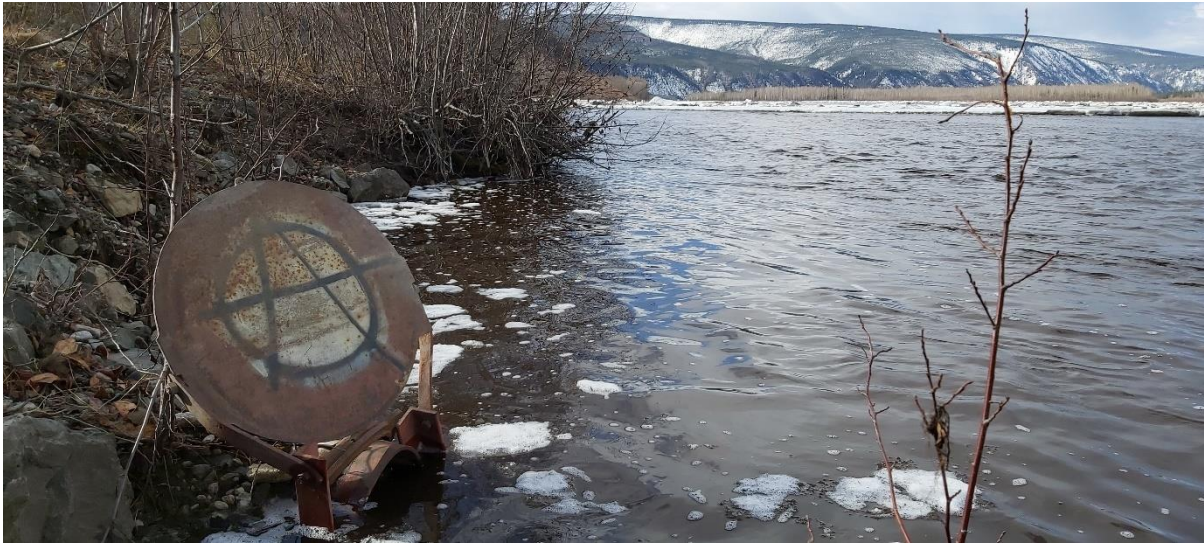
Community	Dawson		
ID #	10		
Asset	Storm Drain Turner St.		
Location	River side of dike, aligned with Turner St.

Surveyed feature	Top of drain		
Elevation	315.7 m	Flood return period	(river side of dike) 0.3 years
Note: Elevation of lowest manhole connected to this drain is 318.5 m		Annual flood probability	(river side of dike) 400 %

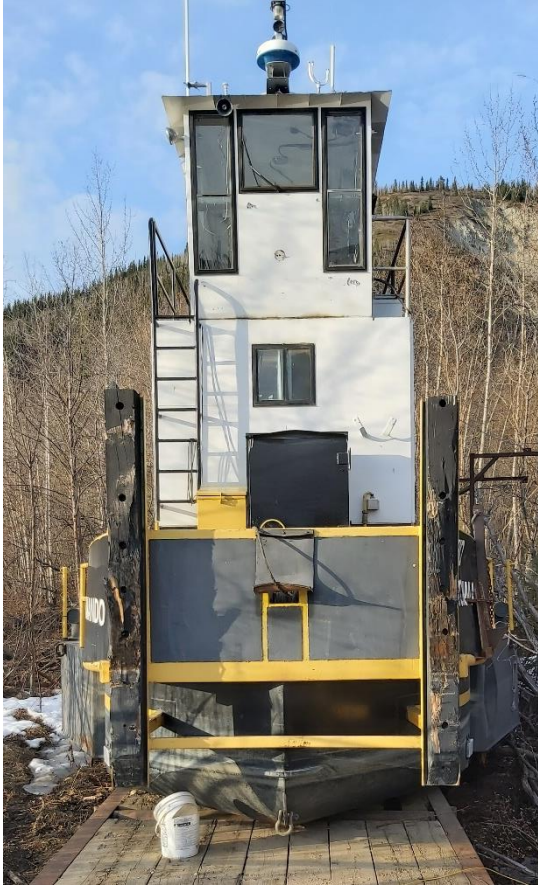
Community	Dawson		
ID #	11		
Asset	Ship on trailer		
Location	North end of community (location at breakup)

Surveyed feature	Approximate floating line		
Elevation	318.8 m	Float return period	(river side of dike) 45
Note: This is a mobile asset, and it could be moved or anchored properly to resist a major flood	Annual float probability	(river side of dike)	2 %

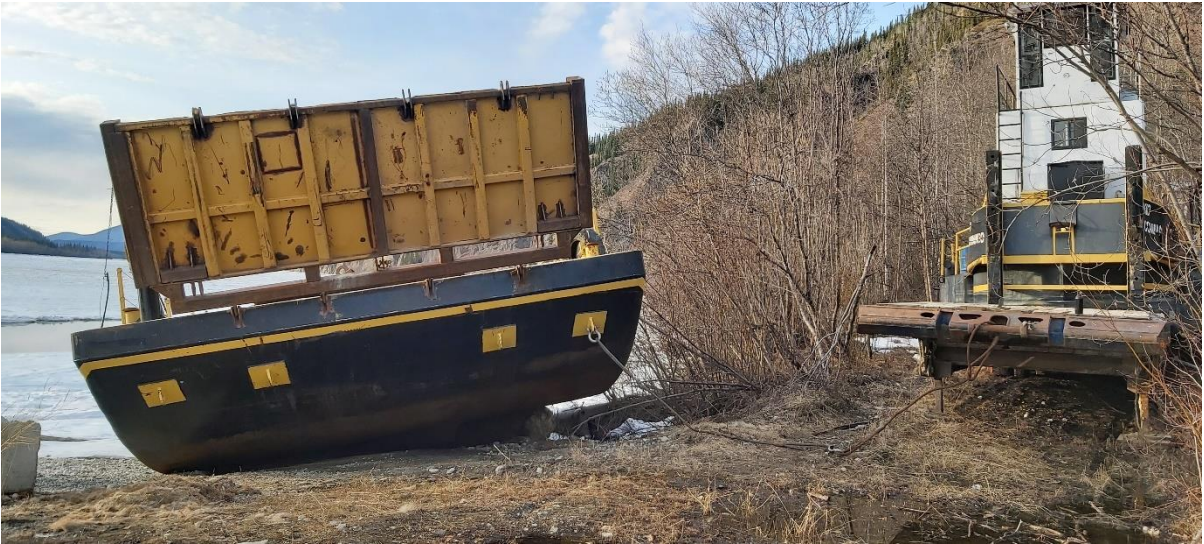
Community	Dawson		
ID #	12		
Asset	Barge, anchored to trailer		
Location	North end of community (location at breakup)

Surveyed feature	Approximate floating line		
Elevation	316.4 m	Float return period	(river side of dike) 2
Note: This is a mobile asset, and it could be moved or anchored properly to resist a major flood		Annual float probability	(river side of dike) 57%

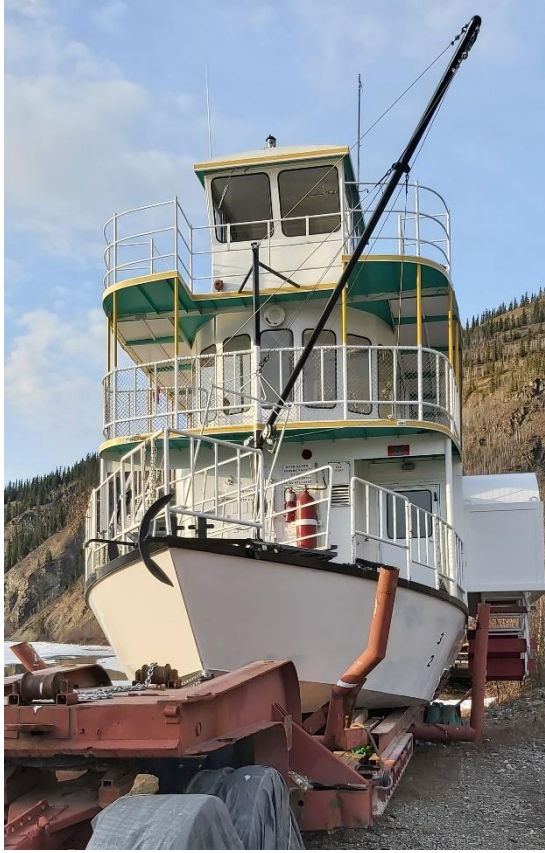
Community	Dawson		
ID #	13		
Asset	Tourist ship, three floors, white		
Location	North end of community (location at breakup)

Surveyed feature	Approximate floating line		
Elevation	319.0 m	Float return period	(river side of dike) 50
Note: This is a mobile asset, and it could be moved or anchored properly to resist a major flood		Annual float probability	(river side of dike) 2%

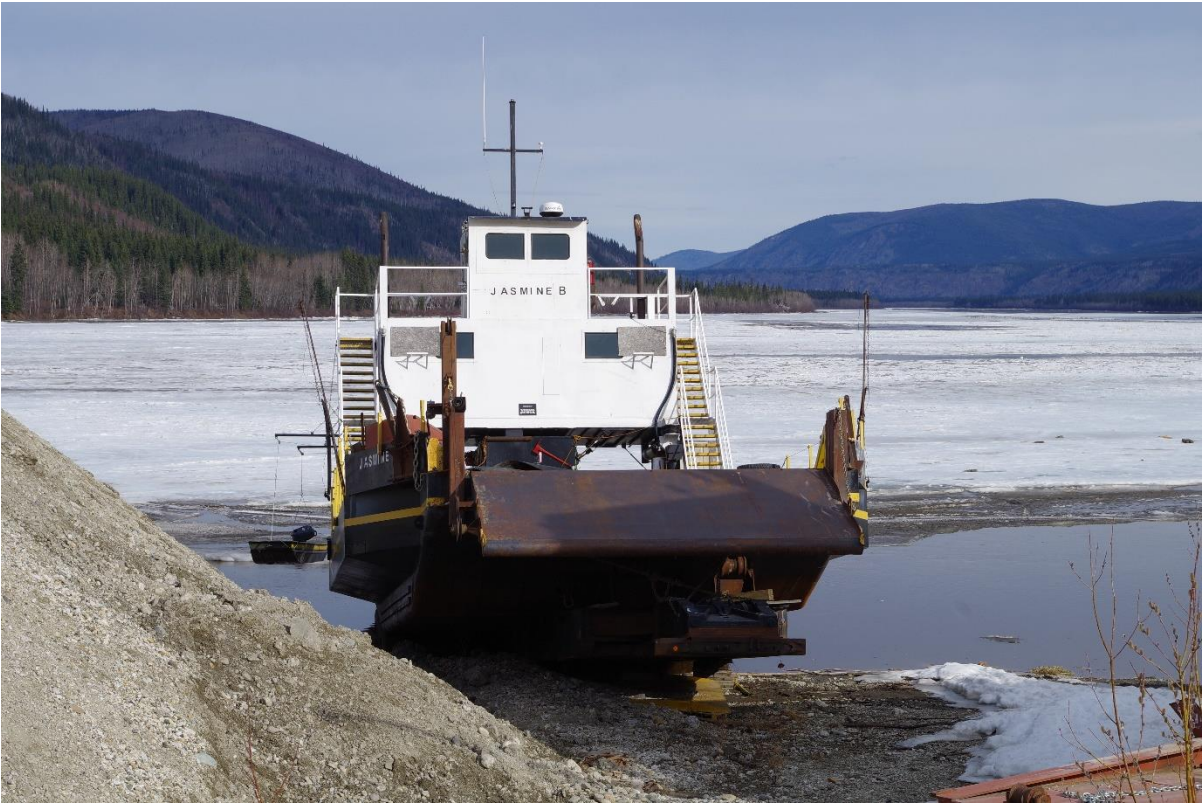
Community	Dawson			
ID #	14			
Asset	Barge or ship, Jasmine B			
Location	North end of community (location at breakup)

Surveyed feature	Approximate floating line			
Elevation	318.4 m	Float return period	(river side of dike)	25
Note: This is a mobile asset, and it could be moved or anchored properly to resist a major flood. In this position, it is expose to ice runs and ice jamming (even more the small boat hanging on the left).		Annual float probability	(river side of dike)	4%

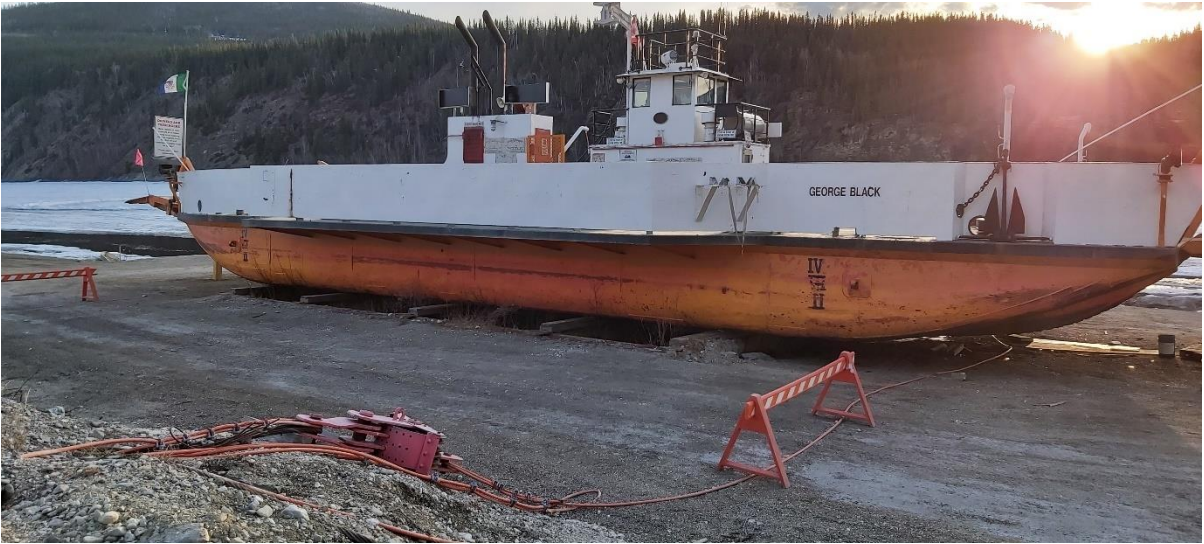
Community	Dawson			
ID #	15			
Asset	George Black Ferry			
Location	Top of dike, between Albert St. and Duke St. (location at breakup)

Surveyed feature	Approximate floating line			
Elevation	320.3 m	Float return period	(river side of dike)	145
Note: This asset could be anchored properly to resist a major ice jam.		Annual float probability	(river side of dike)	0.7%

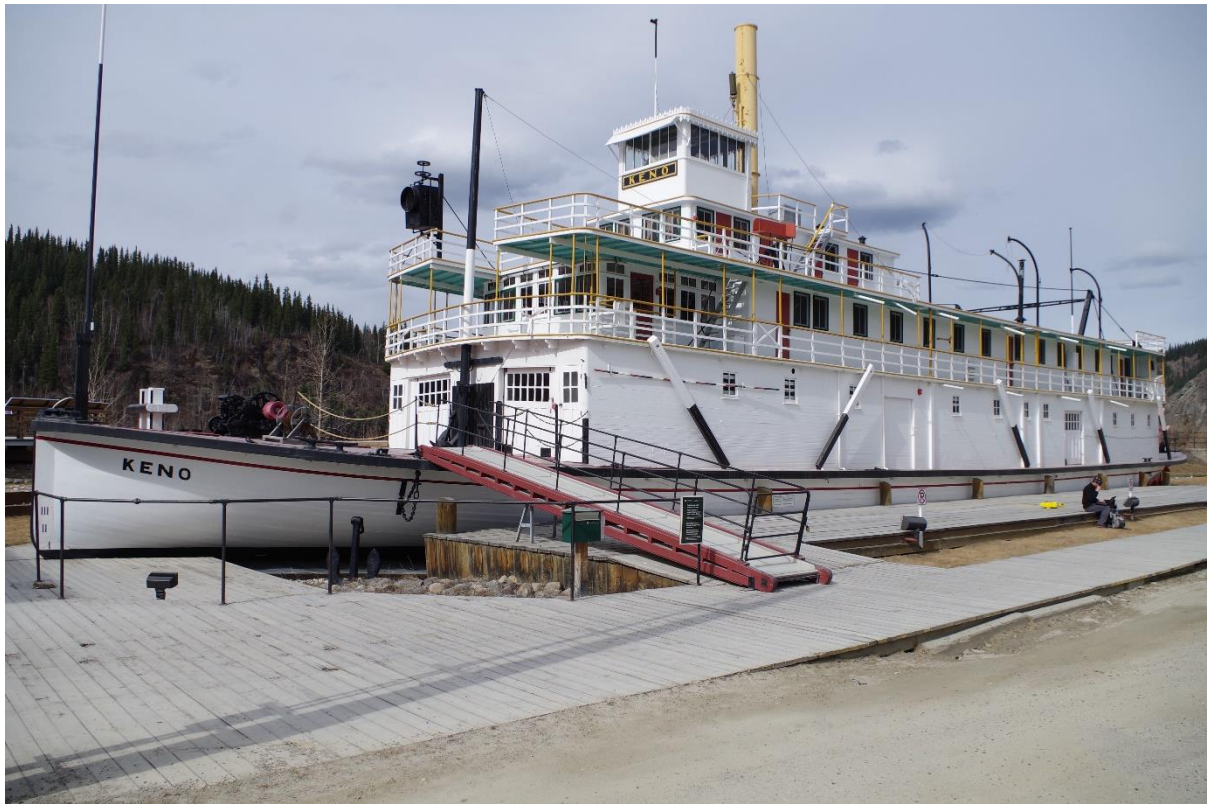
Community	Dawson
ID #	16
Asset	Keno (Park Canada)
Location	Downtown side of dike, beside dike, between King St. and Queen St.

Surveyed feature	Approximate floating line (red line below first deck)			
Elevation	319.7 m	Flood return period	Open storm drains	75 years
Note: It is unclear whether the Keno can float freely or not.			Closed storm drains	120 years
			Optimal dike	200 years
		Annual flood probability	Open storm drains	1.4%
Closed storm drains	0.8%			
Optimal dike	0.5%

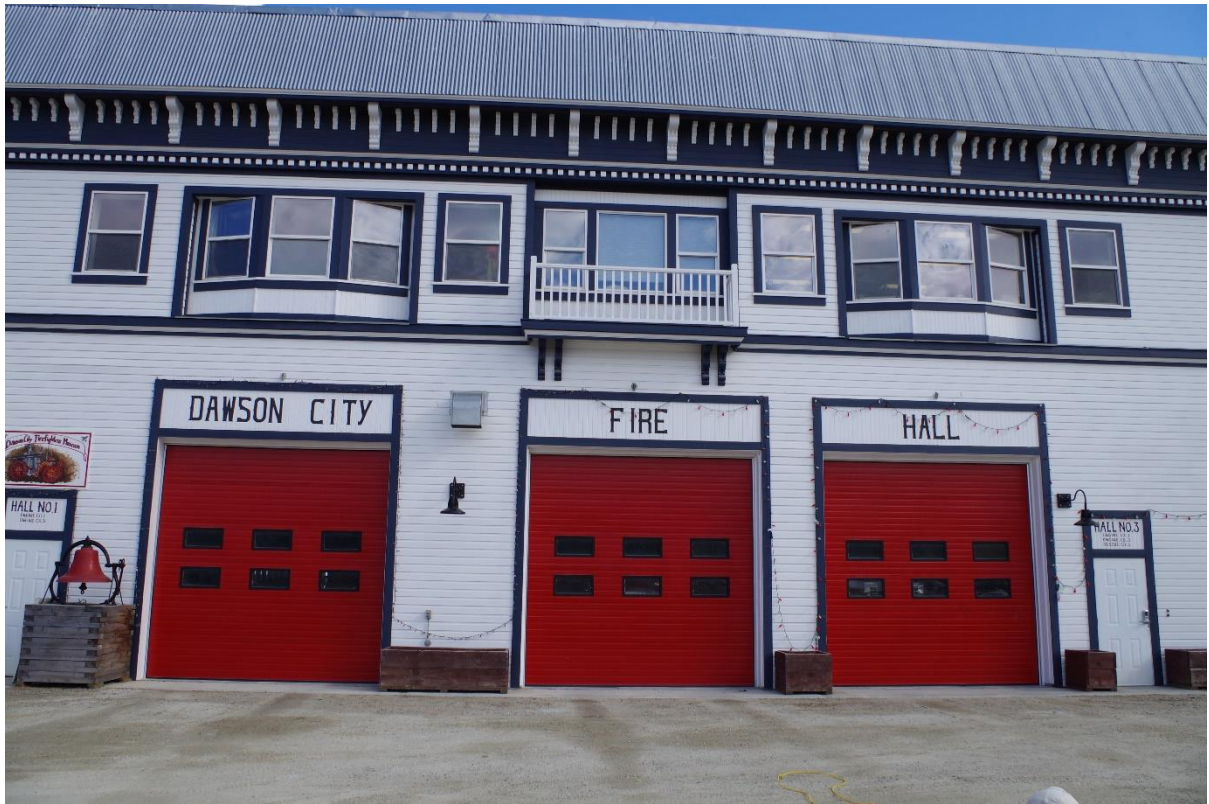
Community	Dawson
ID #	17
Asset	Fire Hall / City of Dawson Building
Location	Front St. / North side of downtown

Surveyed feature	Ground level / First floor			
Elevation	319.7 m	Flood return period	Open storm drains	75 years
			Closed storm drains	120 years
			Optimal dike	200 years
		Annual flood probability	Open storm drains	1.4%
Closed storm drains	0.8%			
Optimal dike	0.5%

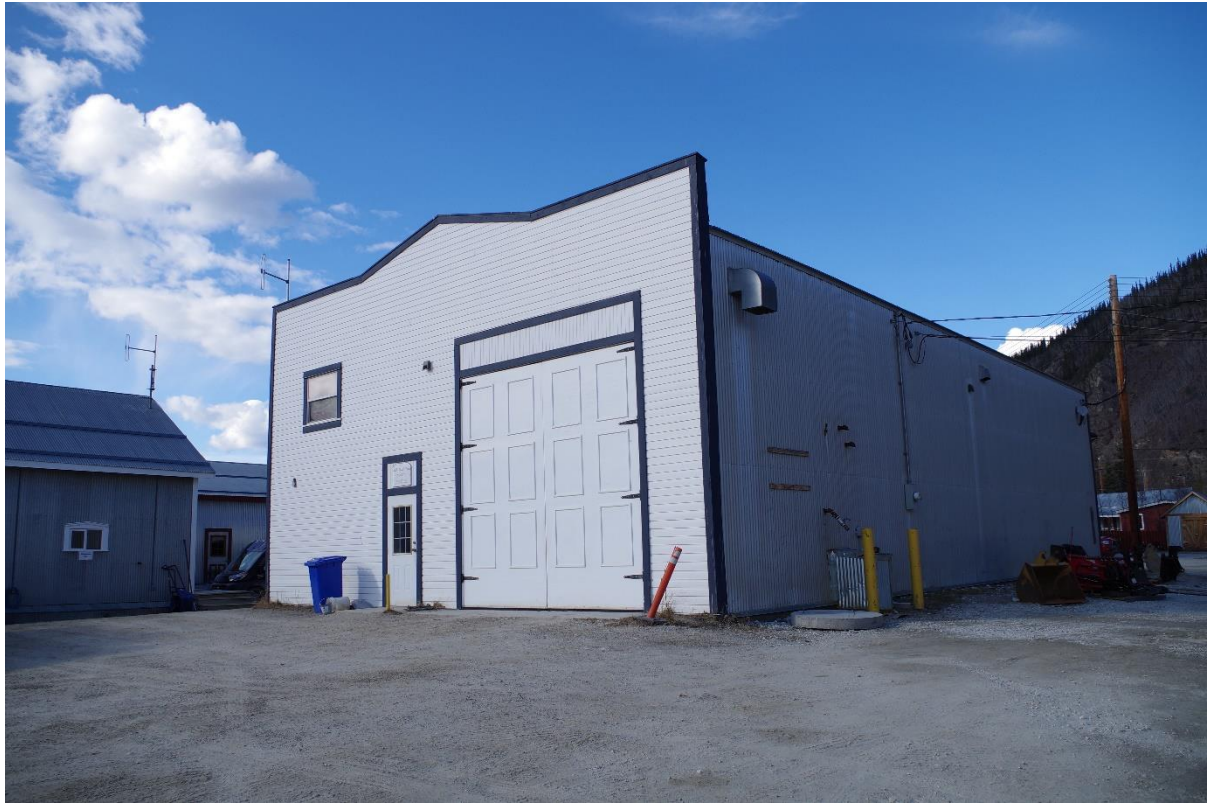
Community	Dawson
ID #	18
Asset	Public Work Garage
Location	Beside Firehall / South side

Surveyed feature	First floor / Concrete slab			
Elevation	319.9 m	Flood return period	Open storm drains	95 years
			Closed storm drains	120 years
			Optimal dike	200 years
		Annual flood probability	Open storm drains	1.0%
	Closed storm drains		0.8%	
	Optimal dike		0.5%

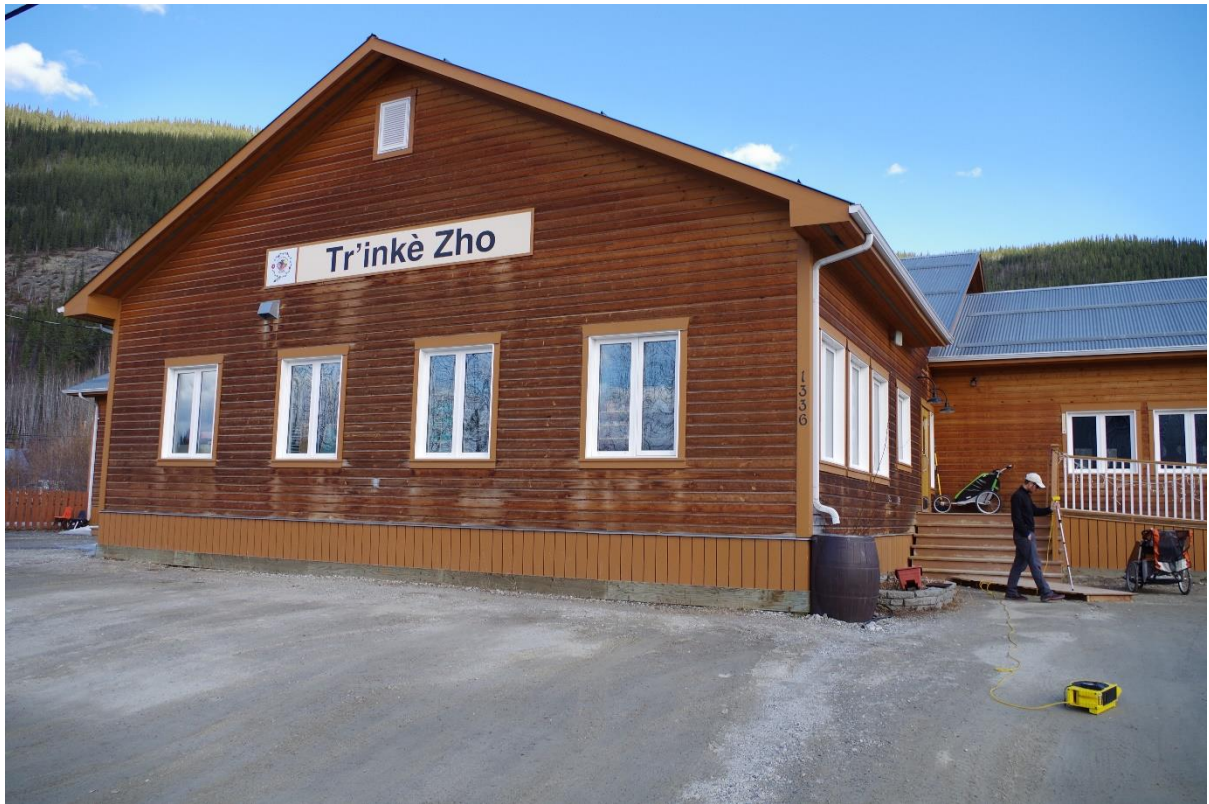
Community	Dawson
ID #	19-20
Asset	New Tr'inkè Zho Daycare
Location	Behind Firehall / Second Ave.

Surveyed feature	First floor / top of stairs (Bottom of outside stairs / Parking)			
Elevation	320.6 m (319.4 m)	Flood return period	Open storm drains	200 years (50 years)
			Closed storm drains	200 years (120 years)
Optimal dike	200 years			
		Annual flood probability	Open storm drains	0.5% (2%)
			Closed storm drains	0.5% (0.8%)
			Optimal dike	0.5%

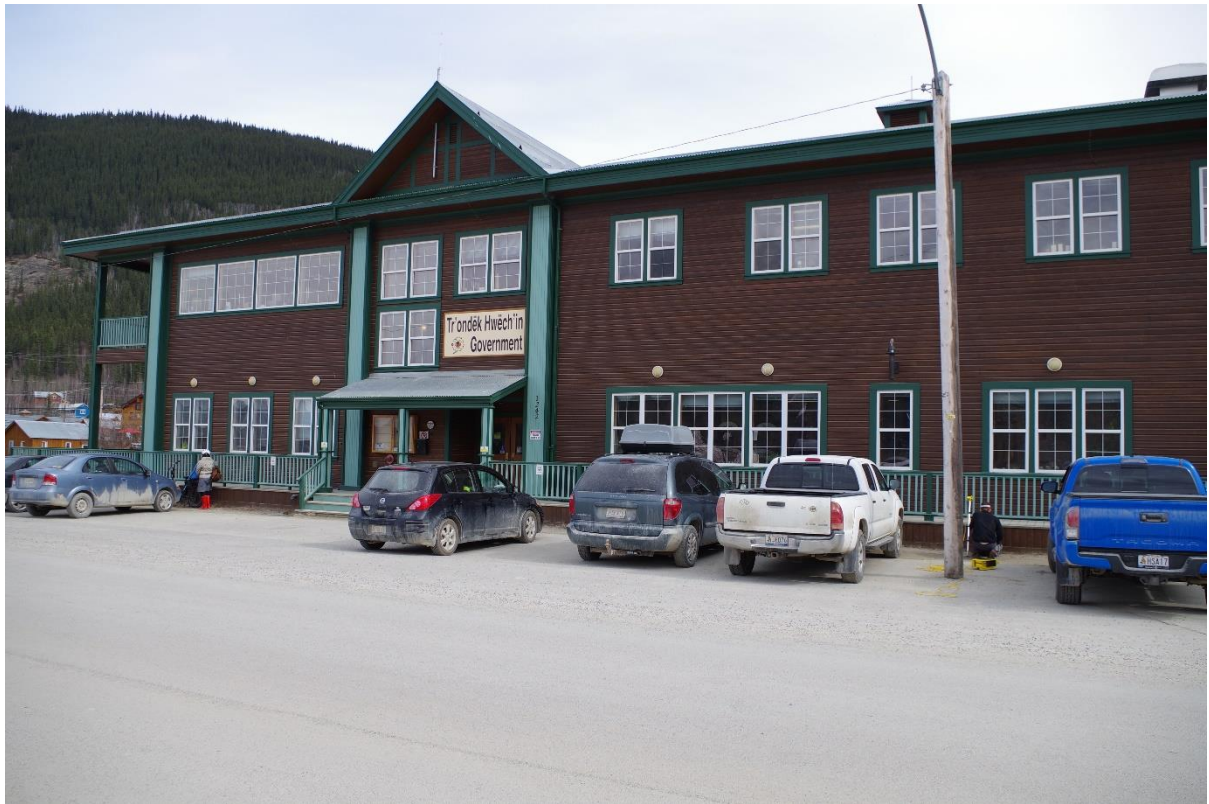
Community	Dawson
ID #	21
Asset	Tr'ondëk Hwëch'in Government
Location	Front St. between Duke St. and York St.

Surveyed feature	First Floor / Main entrance / Top of outdoor stairs			
Elevation	320.5 m		Open storm drains	195 years
		Flood return period	Closed storm drains	195 years
			Optimal dike	200 years
			Annual flood probability	Open storm drains
		Closed storm drains		0.5%
		Optimal dike		0.5%

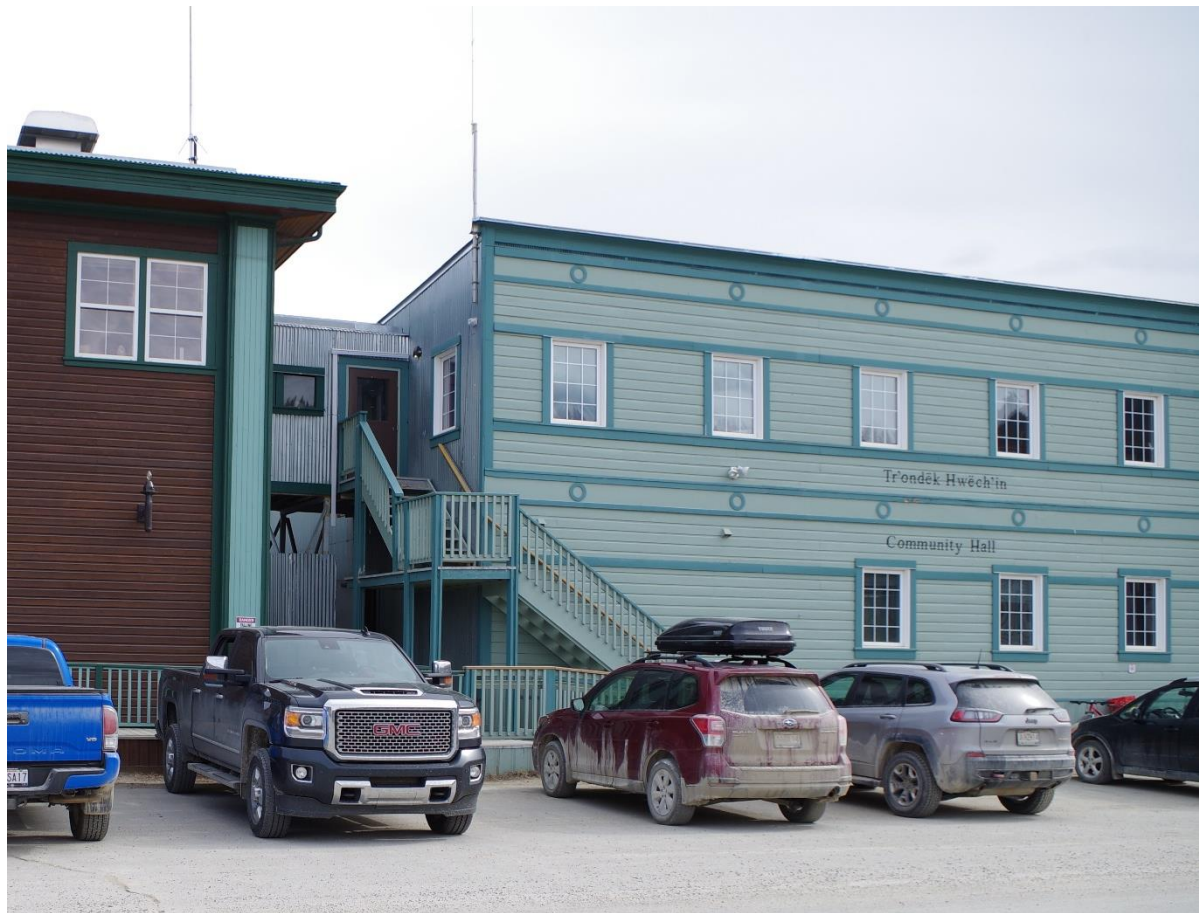
Community	Dawson
ID #	22
Asset	Tr'ondëk Hwëch'in Community Hall
Location	Front St. besides Tr'ondëk Hwëch'in Government building

Surveyed feature	First Floor / Top of outdoor stairs and ramp			
Elevation	321.0 m		Open storm drains	250 years
		Flood return period	Closed storm drains	250 years
			Optimal dike	250 years
			Annual flood probability	Open storm drains
		Closed storm drains		0.4%
		Optimal dike		0.4%
