# Flooding in Dawson: Exposure analysis and risk reduction recommendations

March | 2022

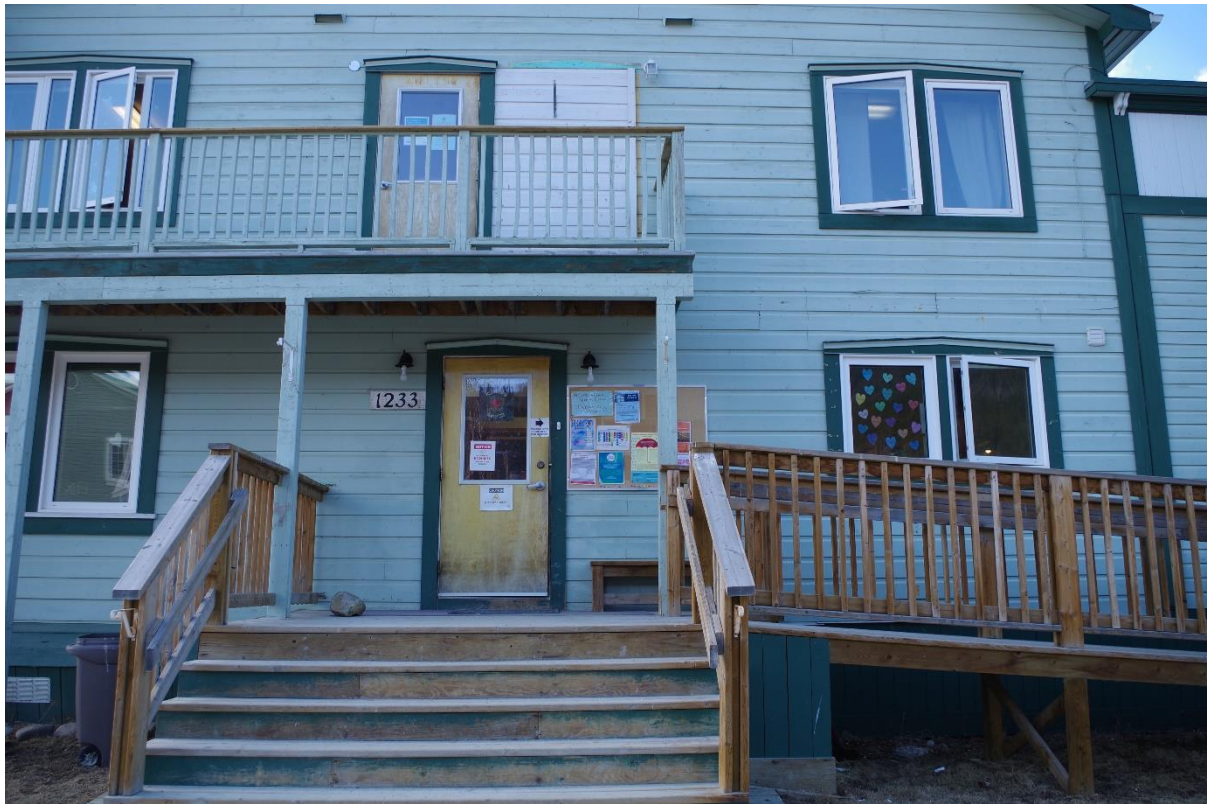
Community	Dawson
ID #	23
Asset	Wellness Centre
Location	Second Ave. between Duke St. and York St.

Surveyed feature	First Floor / Main entrance / Top of outdoor stairs				
Elevation	320.6 m	Flood return period	Open storm drains	200 years	
				Closed storm drains	200 years
				Optimal dike	200 years
		Annual flood probability		Open storm drains	0.5%
	Closed storm drains		0.5%		
	Optimal dike		0.5%

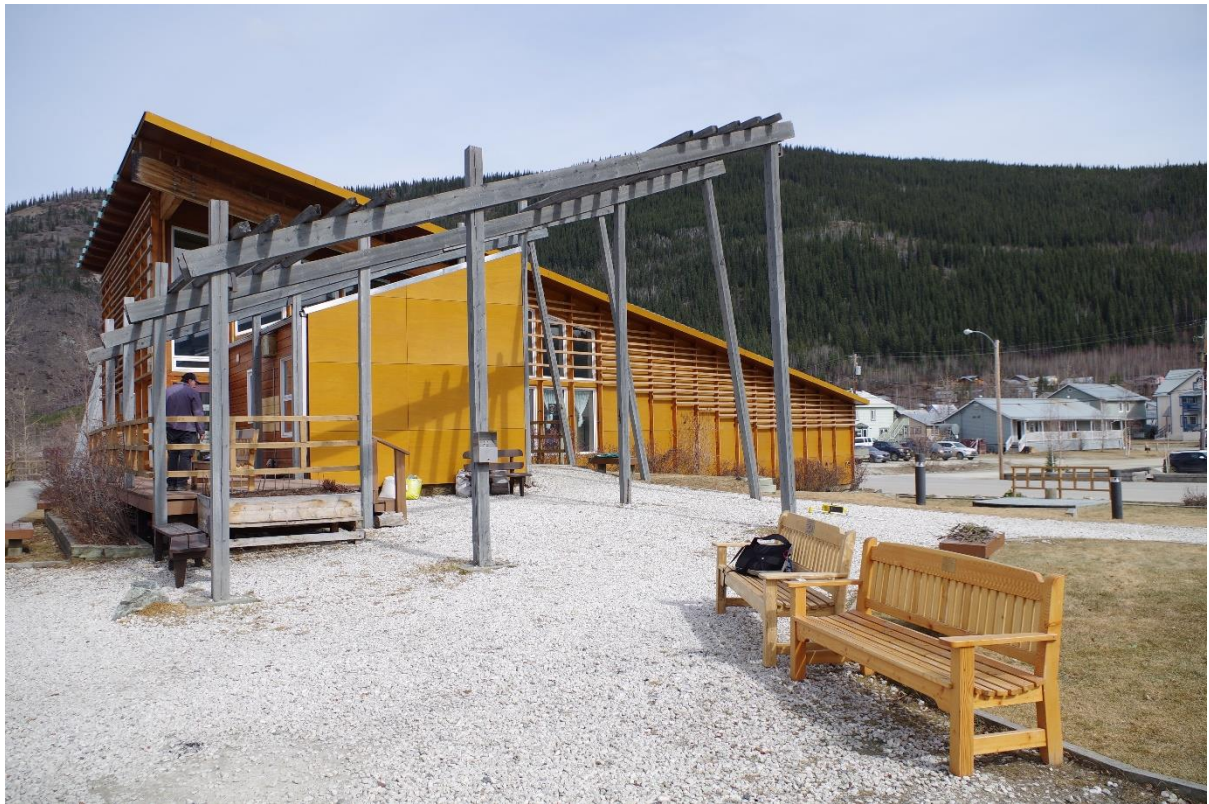
Community	Dawson
ID #	24-25
Asset	Dänojà Zho Cultural Centre (and theater)
Location	Dike / Maint St. / across York St.

Surveyed feature	First Floor / Main entrance (Lower Theater level, assumed floor elev.)			
Elevation	321.7 m (319.7 m)	Flood return period	Open storm drains	400 years (75 years)
			Closed storm drains	400 years (120 years)
			Optimal dike	400 years (200 years)
		Annual flood probability	Open storm drains	0.25% (1.4%)
			Closed storm drains	0.25% (0.8%)
			Optimal dike	0.25% (0.4%)

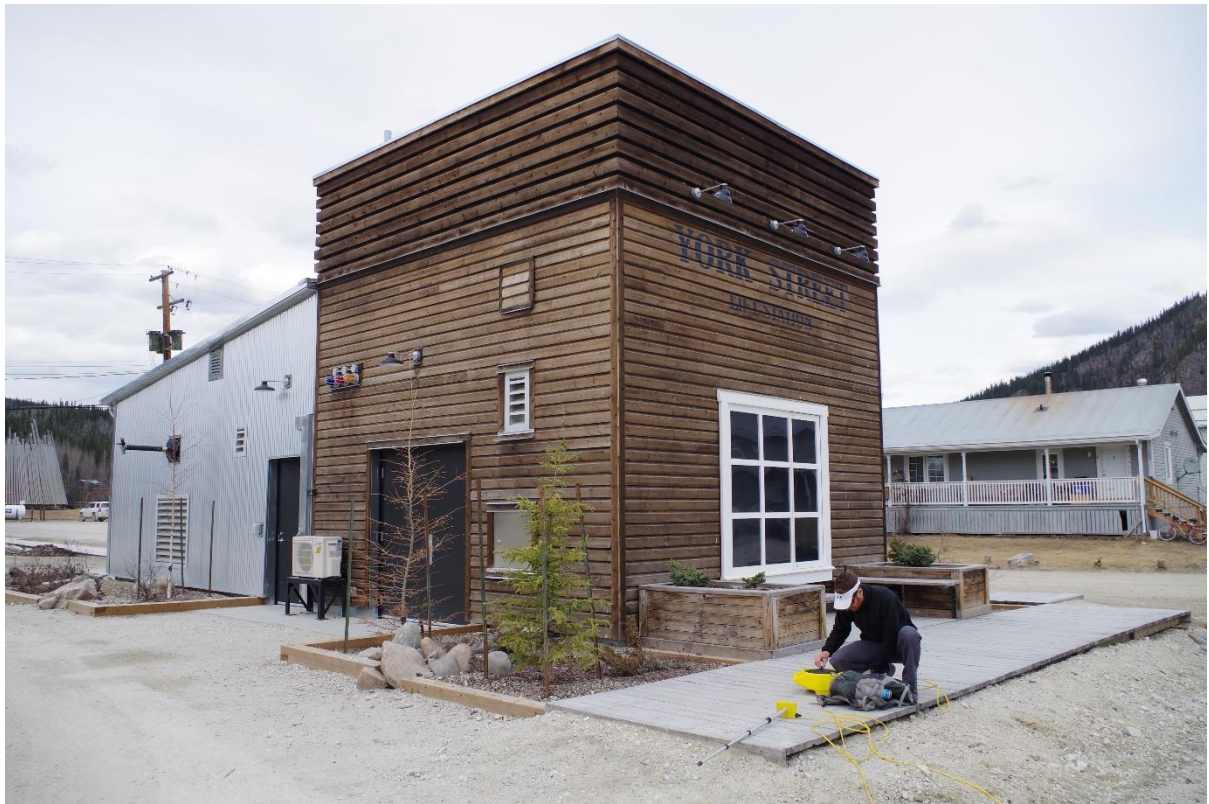
Community	Dawson
ID #	26
Asset	Lift station
Location	York St. and 2 <sup>nd</sup> Ave.

Surveyed feature	First floor / Concrete slab / Level of lower electronics		
Elevation	319.4 m		Open storm drains 50 years
		Flood return period	Closed storm drains 120 years
			Optimal dike 200 years
		Annual flood probability	Open storm drains 2%
			Closed storm drains 0.8%
			Optimal dike 0.5%

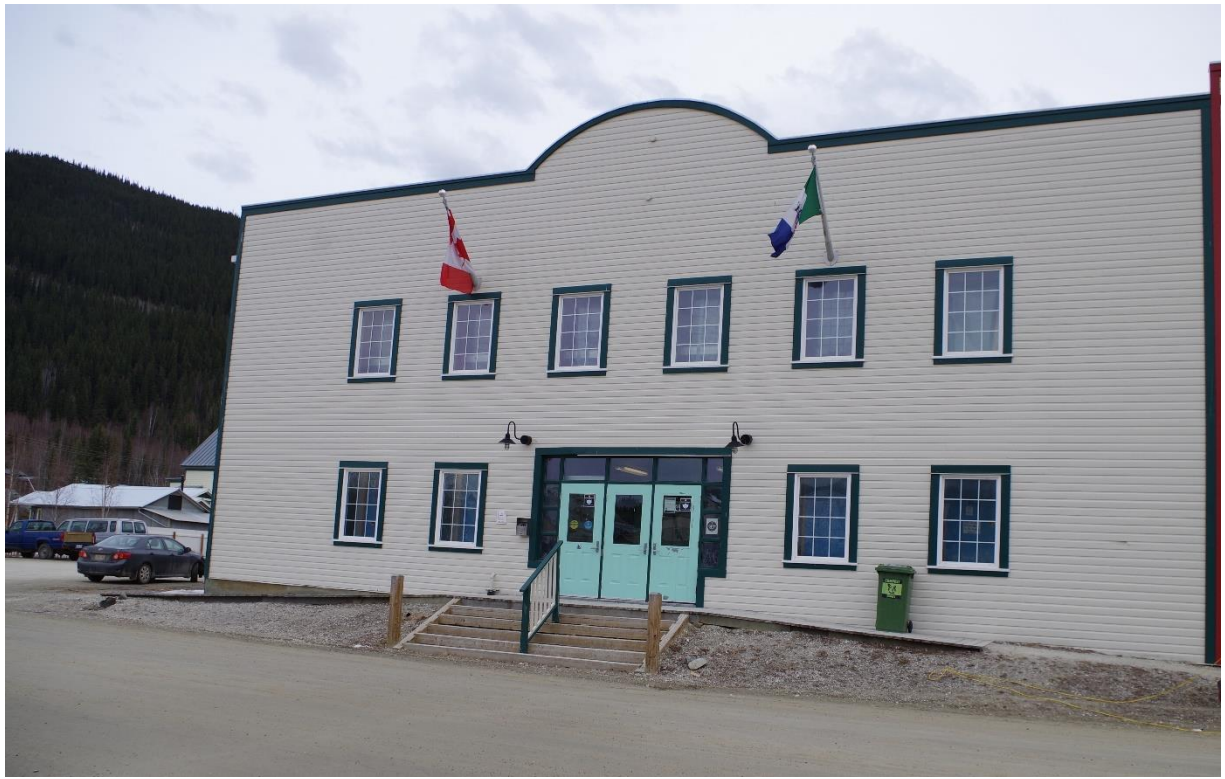
Community	Dawson
ID #	27
Asset	Recreation Centre / North wing
Location	4 <sup>th</sup> Ave.

Surveyed feature	First floor / Main entrance / North side of building			
Elevation	320.1 m	Flood return period	Open storm drains	130 years
			Closed storm drains	145 years
			Optimal dike	200 years
		Annual flood probability	Open storm drains	0.8%
			Closed storm drains	0.7%
			Optimal dike	0.5%

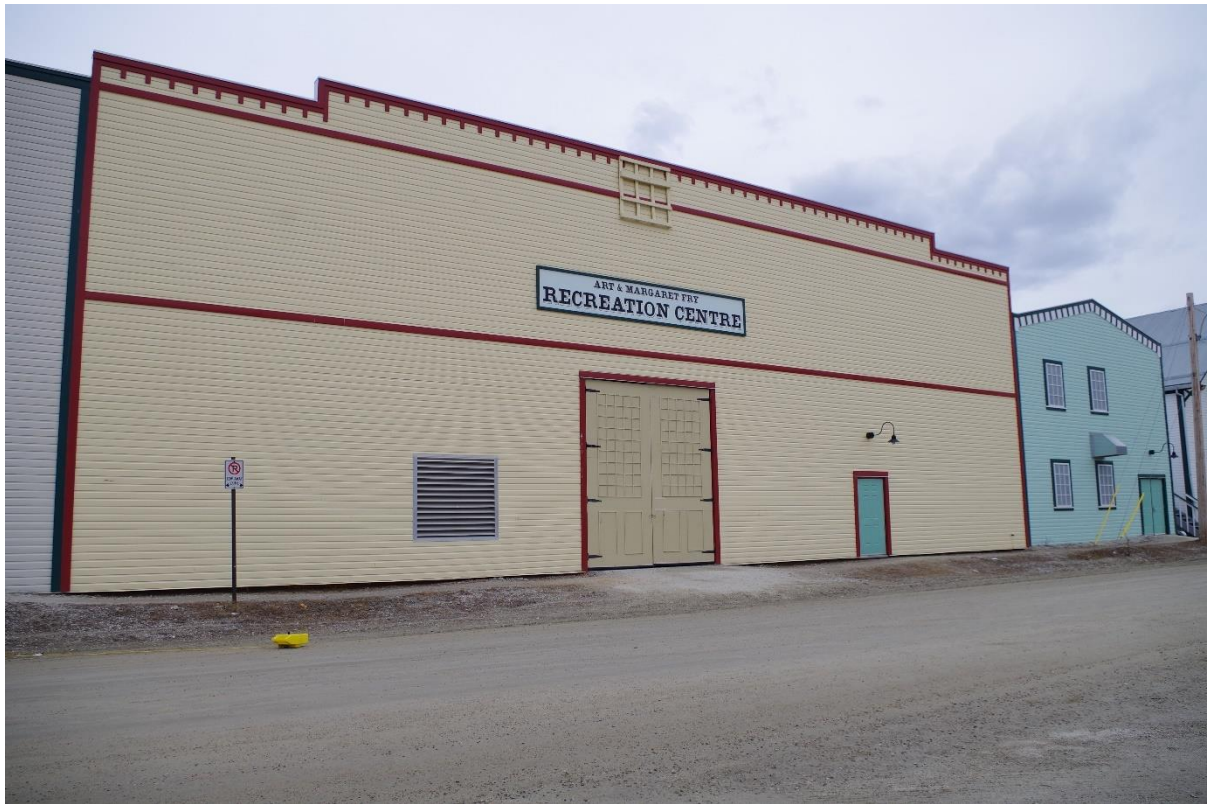
Community	Dawson
ID #	28
Asset	Art and Margaret Fry Recreation Centre / South wing
Location	4 <sup>th</sup> Ave.

Surveyed feature	First floor / West side door / old concrete slab			
Elevation	319.7 m		Open storm drains	75 years
		Flood return period	Closed storm drains	120 years
			Optimal dike	200 years
		Annual flood probability	Open storm drains	1.3%
			Closed storm drains	0.8%
			Optimal dike	0.5%

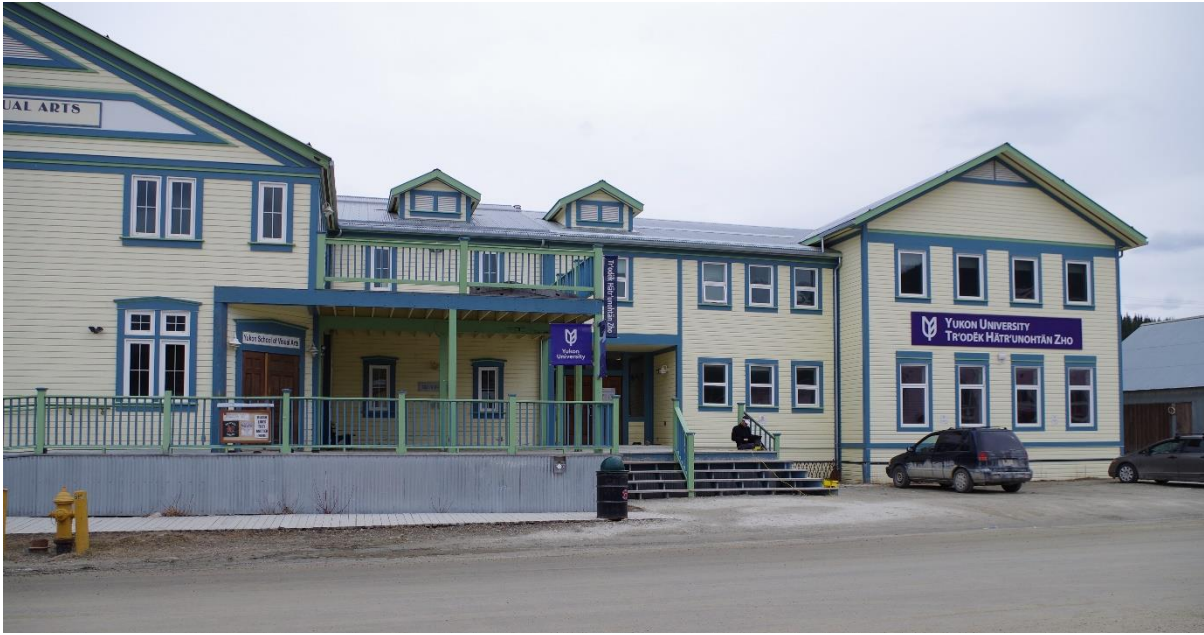
Community	Dawson				
ID #	29				
Asset	Yukon University Tr'odëk Hätr'unohtän Zho Campus				
Location	3 <sup>rd</sup> Ave. and Queen St.

Surveyed feature	First floor / Doorstep / Main entrance				
Elevation	320.6 m	Flood return period	Open storm drains	200 years	
			Annual flood probability	Closed storm drains	200 years
				Optimal dike	200 years
		Open storm drains		0.5%	
			Closed storm drains	0.5%	
			Optimal dike	0.5%

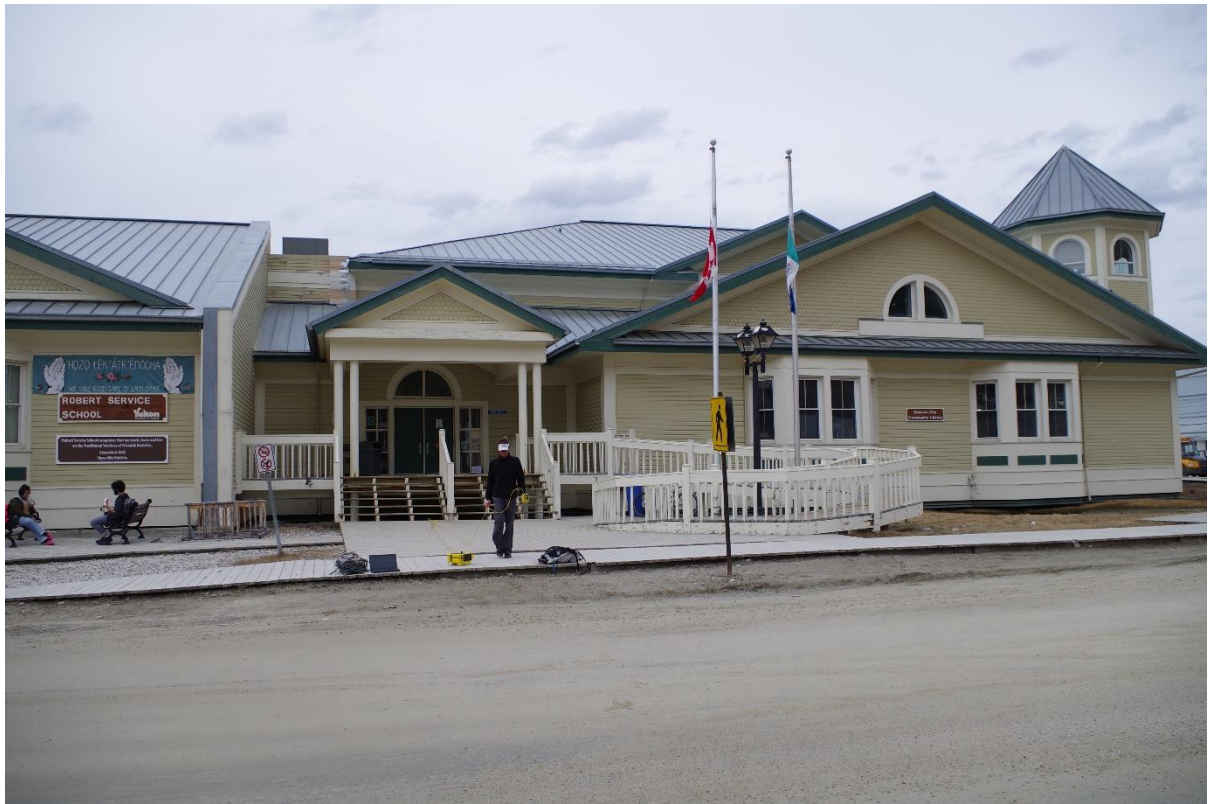
Community	Dawson
ID #	30
Asset	Robert Service School
Location	5 <sup>th</sup> Ave. and Queen St.

Surveyed feature	First floor / Doorstep / Main entrance			
Elevation	320.7 m		Open storm drains	210 years
Note: The school is now painted in orange with yellow and red.	Flood return period		Closed storm drains	210 years
			Optimal dike	210 years
		Annual flood probability		Open storm drains
	Closed storm drains		0.5%	
	Optimal dike		0.5%

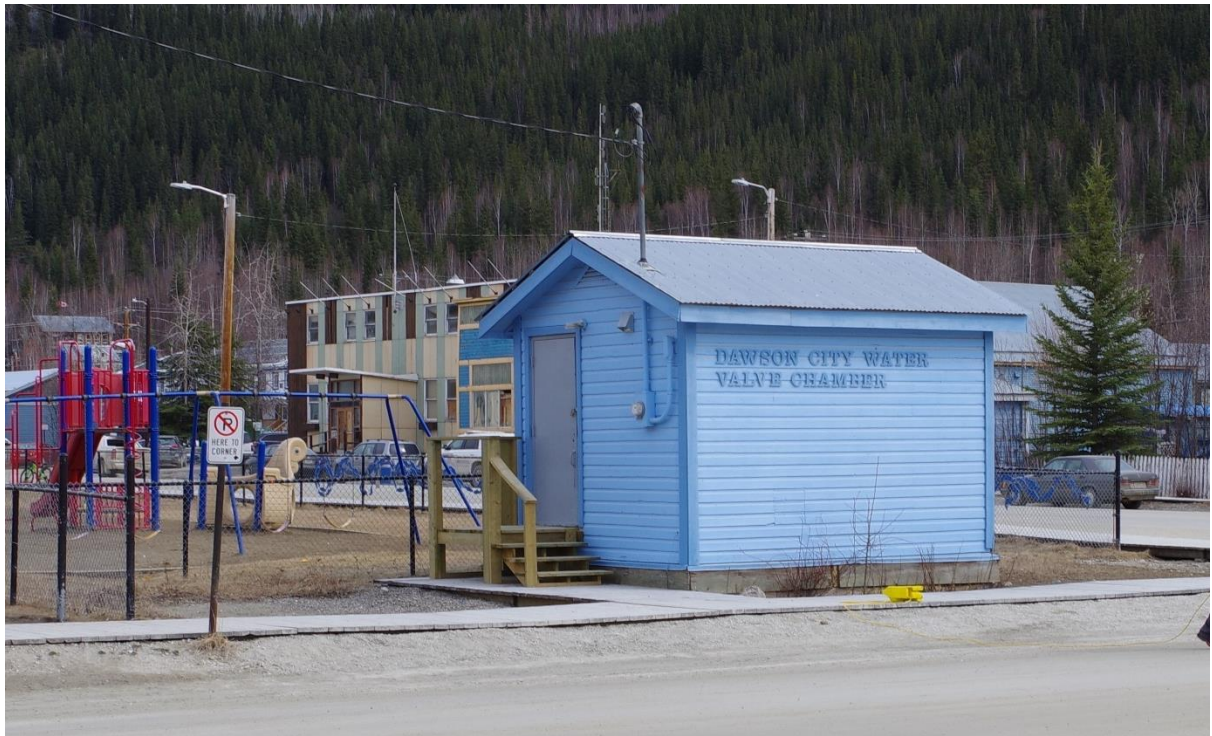
Community	Dawson
ID #	31
Asset	Dawson City Water Valve Chamber
Location	Princess St. and 5 <sup>th</sup> Ave.

Surveyed feature	First floor / Top of stairs			
Elevation	319.9 m	Flood return period	Open storm drains	100 years
			Closed storm drains	120 years
			Optimal dike	200 years
		Annual flood probability	Open storm drains	1.0%
			Closed storm drains	0.8%
			Optimal dike	0.5%

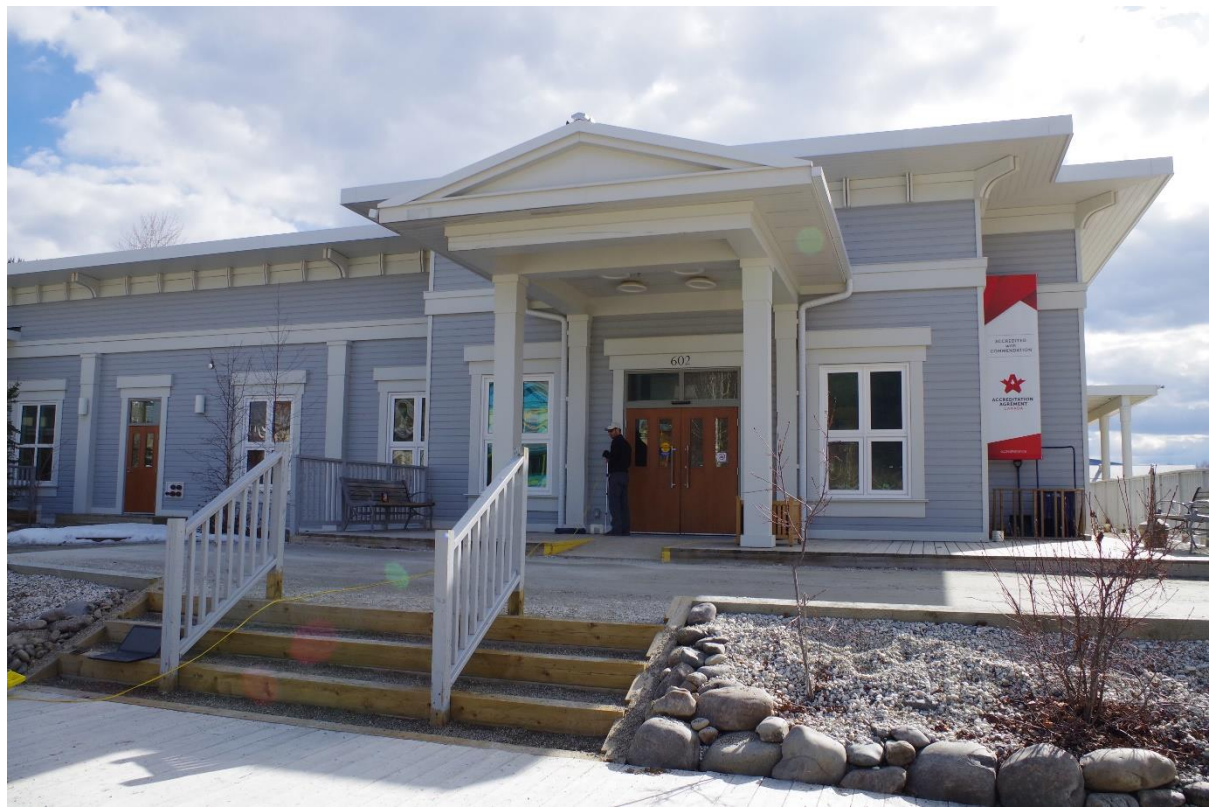
Community	Dawson
ID #	32
Asset	McDonald Residence
Location	Church St. and 7 <sup>th</sup> Ave.

Surveyed feature	First floor / Doorstep			
Elevation	320.4 m	Flood return period	Open storm drains	180 years
			Closed storm drains	180 years
			Optimal dike	200 years
		Annual flood probability	Open storm drains	0.6%
Closed storm drains	0.6%			
Optimal dike	0.5%

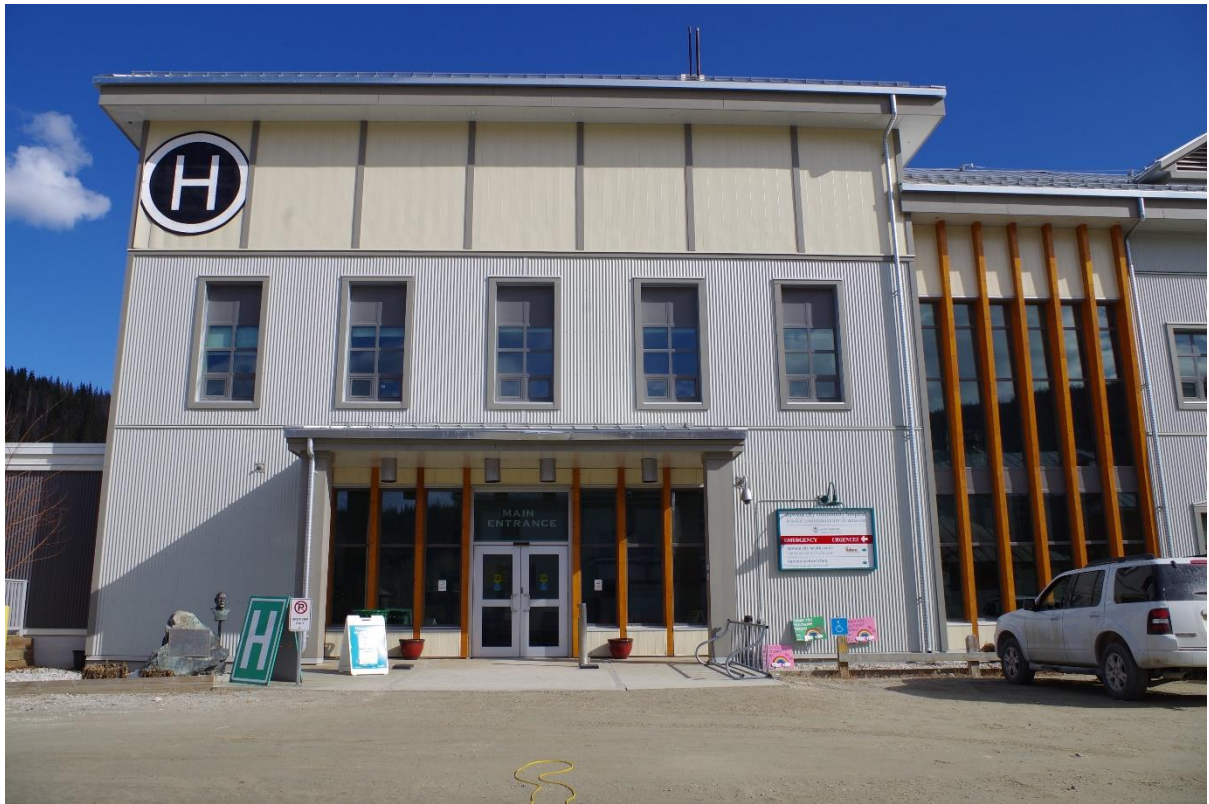
Community	Dawson
ID #	33
Asset	Hospital
Location	Church St. and 6 Ave., behind Museum

Surveyed feature	First floor / Doorstep			
Elevation	320.0 m	Flood return period	Open storm drains	110 years
Note: Measurements indicate that the McDonald Residence attached to the Hospital is 0.4 m higher.			Closed storm drains	125 years
			Optimal dike	200 years
		Annual flood probability	Open storm drains	0.9%
Closed storm drains	0.8%			
Optimal dike	0.5%

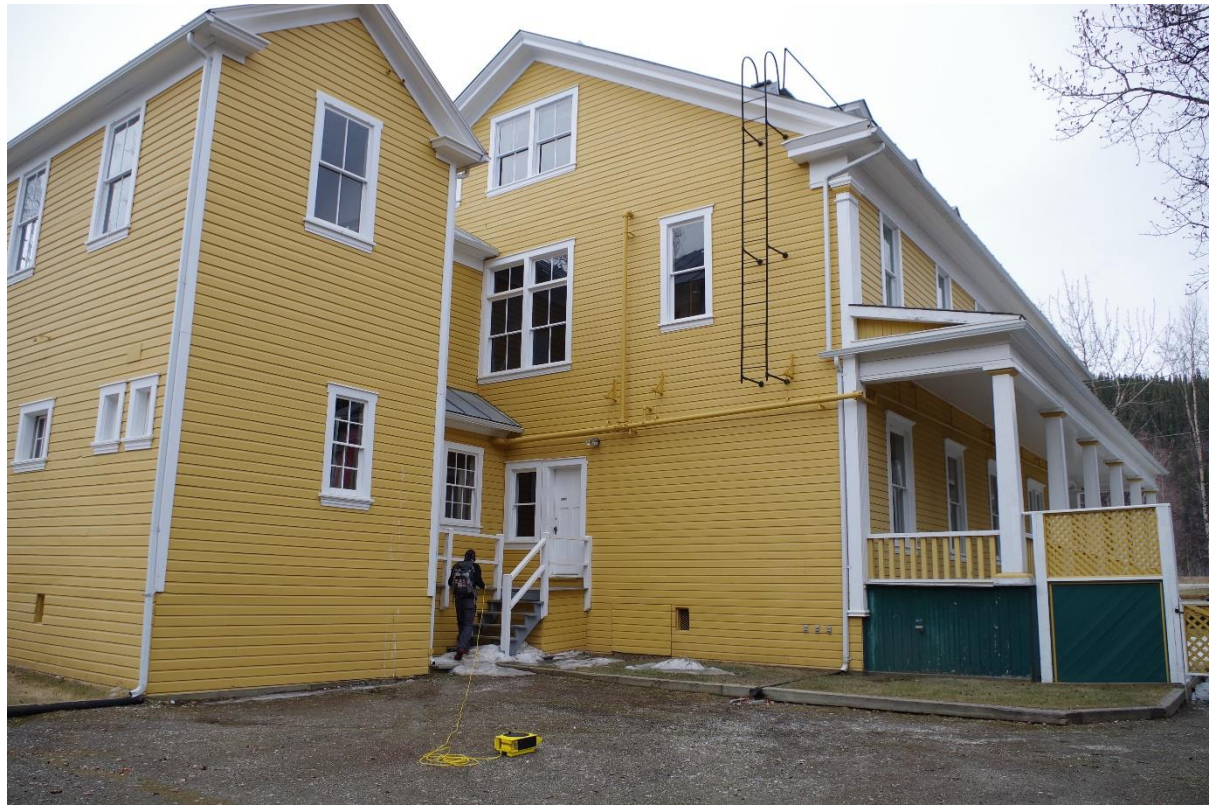
Community	Dawson
ID #	34
Asset	Governor's House
Location	Front St. south of Church St.

Surveyed feature	First floor / Top of outdoor stairs				
Elevation	319.8 m	Flood return period	Open storm drains	90 years	
Note: Photo taken from the back			Annual flood probability	Closed storm drains	120 years
				Optimal dike	200 years
		Open storm drains		1.1%	
			Closed storm drains	0.8%	
			Optimal dike	0.5%

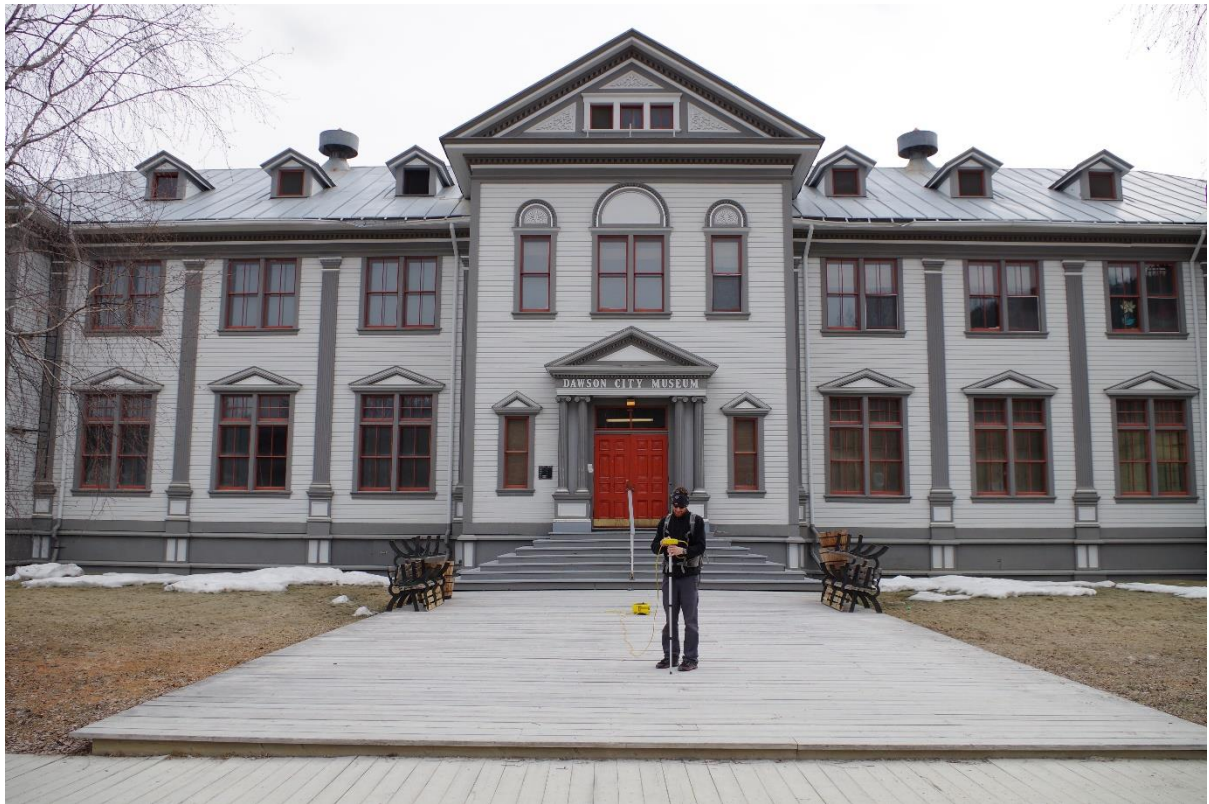
Community	Dawson
ID #	35
Asset	Museum
Location	5 <sup>th</sup> Ave. south of Church St.

Surveyed feature	First floor / Top of outdoor stairs			
Elevation	320.3 m	Flood return period	Open storm drains	160 years
			Closed storm drains	160 years
			Optimal dike	200 years
		Annual flood probability	Open storm drains	0.6%
Closed storm drains	0.6%			
Optimal dike	0.5%

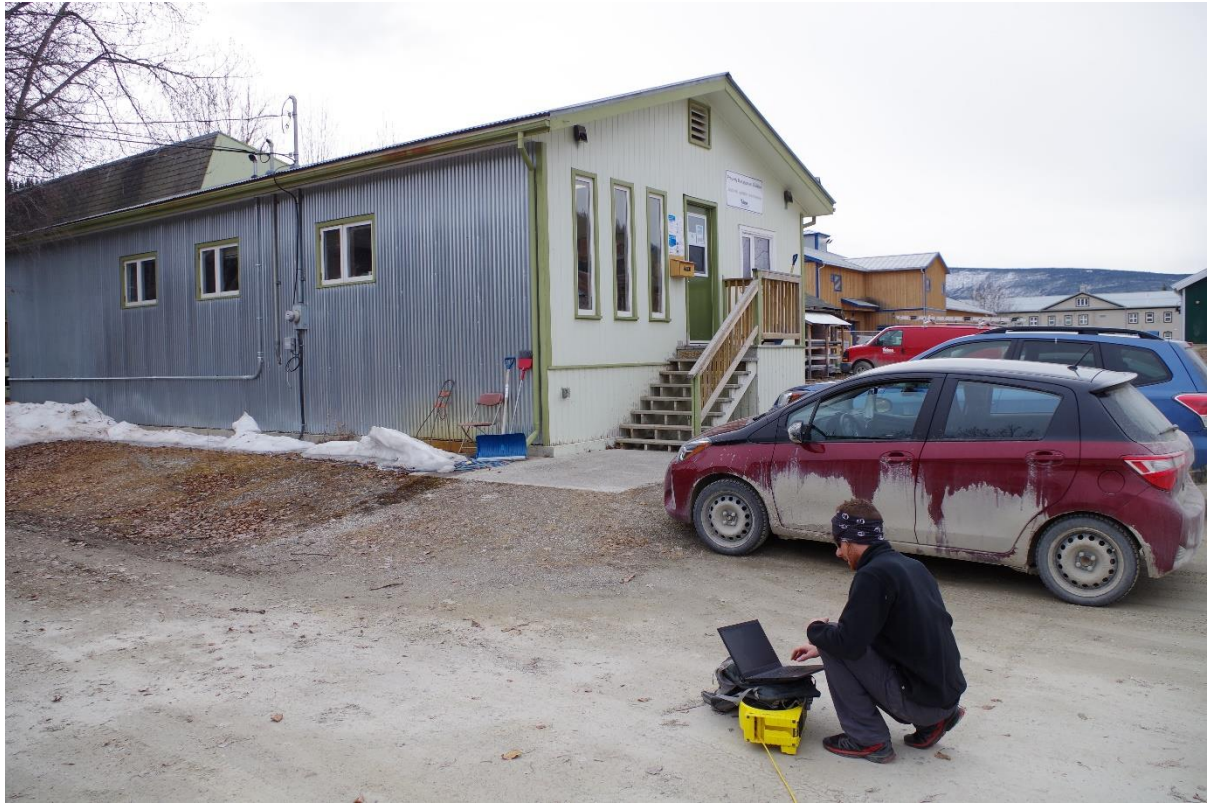
Community	Dawson
ID #	36
Asset	Yukon Government Property Management Division
Location	5 <sup>th</sup> Ave. front of Museum (access in the back)

Surveyed feature	First floor / Top of outdoor stairs			
Elevation	319.9 m	Flood return period	Open storm drains	100 years
Note: Photo taken from main entrance, at the back.			Closed storm drains	120 years
			Optimal dike	200 years
		Annual flood probability	Open storm drains	1.0%
Closed storm drains	0.8%			
Optimal dike	0.5%

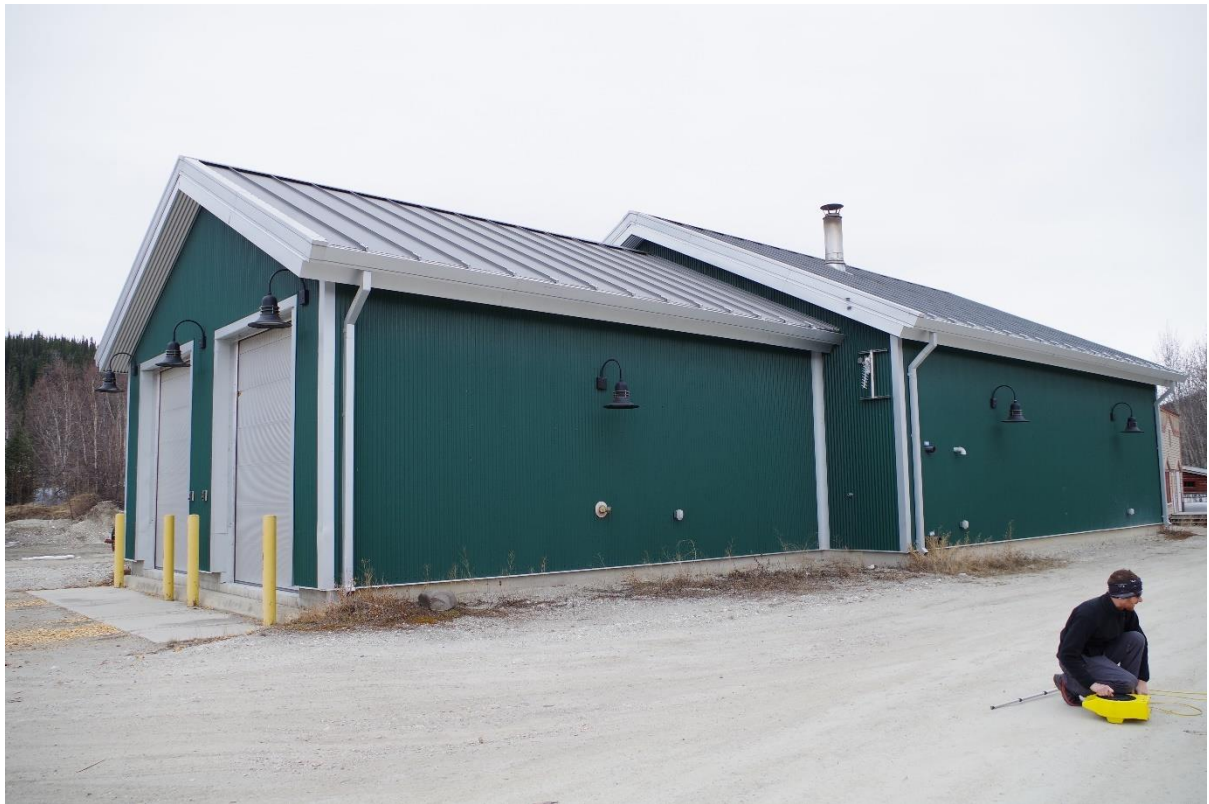
Community	Dawson
ID #	37
Asset	Green garage behind Sewage Treatment Plant
Location	5 <sup>th</sup> Ave. front of park, behind Sewage Treatment Plant

Surveyed feature	Bottom of garage door / main floor			
Elevation	319.7 m	Flood return period	Open storm drains	75 years
			Closed storm drains	120 years
			Optimal dike	200 years
		Annual flood probability	Open storm drains	1.3%
			Closed storm drains	0.8%
			Optimal dike	0.5%

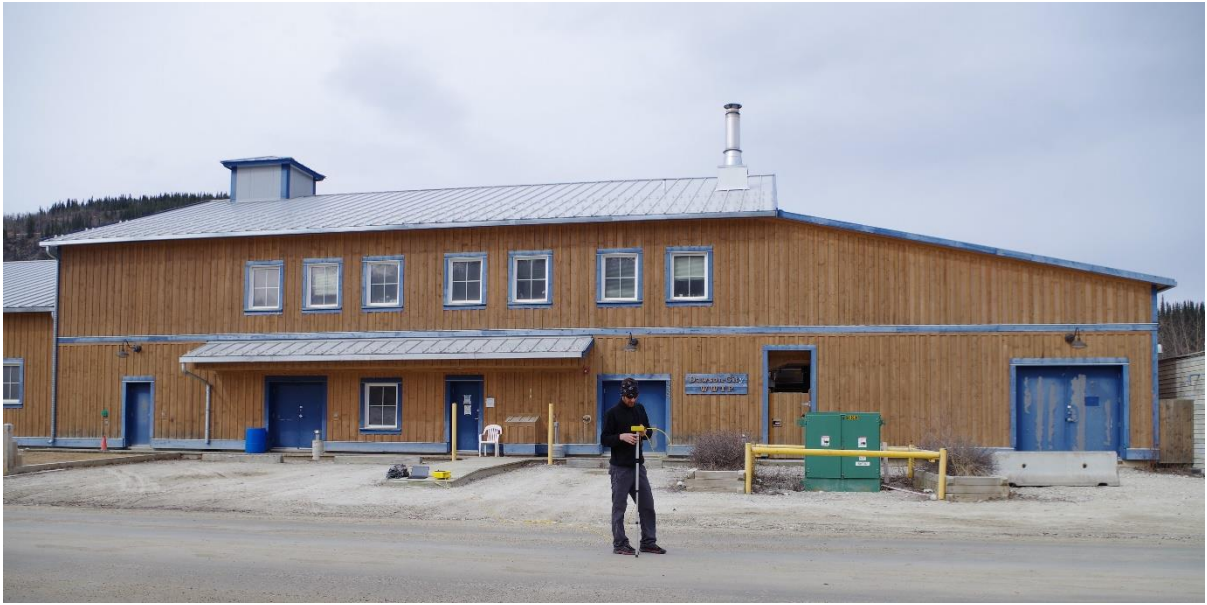
Community	Dawson			
ID #	38			
Asset	Sewage Treatment Plant			
Location	5 <sup>th</sup> Ave. front of Museum

Surveyed feature	First floor / Doorstep (wood slab below large blue door at the back)			
Elevation	319.4 m (319.6 m)	Flood return period	Open storm drains	50 years (65 years)
Note: There is uncertainty here regarding level of main floor since back and front elevations do not correspond (0.2 m difference). This may be due to street grading combined with expect DEM accuracy.			Closed storm drains	120 years
			Optimal dike	200 years
		Annual flood probability	Open storm drains	2.0% (1.5%)
Closed storm drains	0.8%			
Optimal dike	0.5%

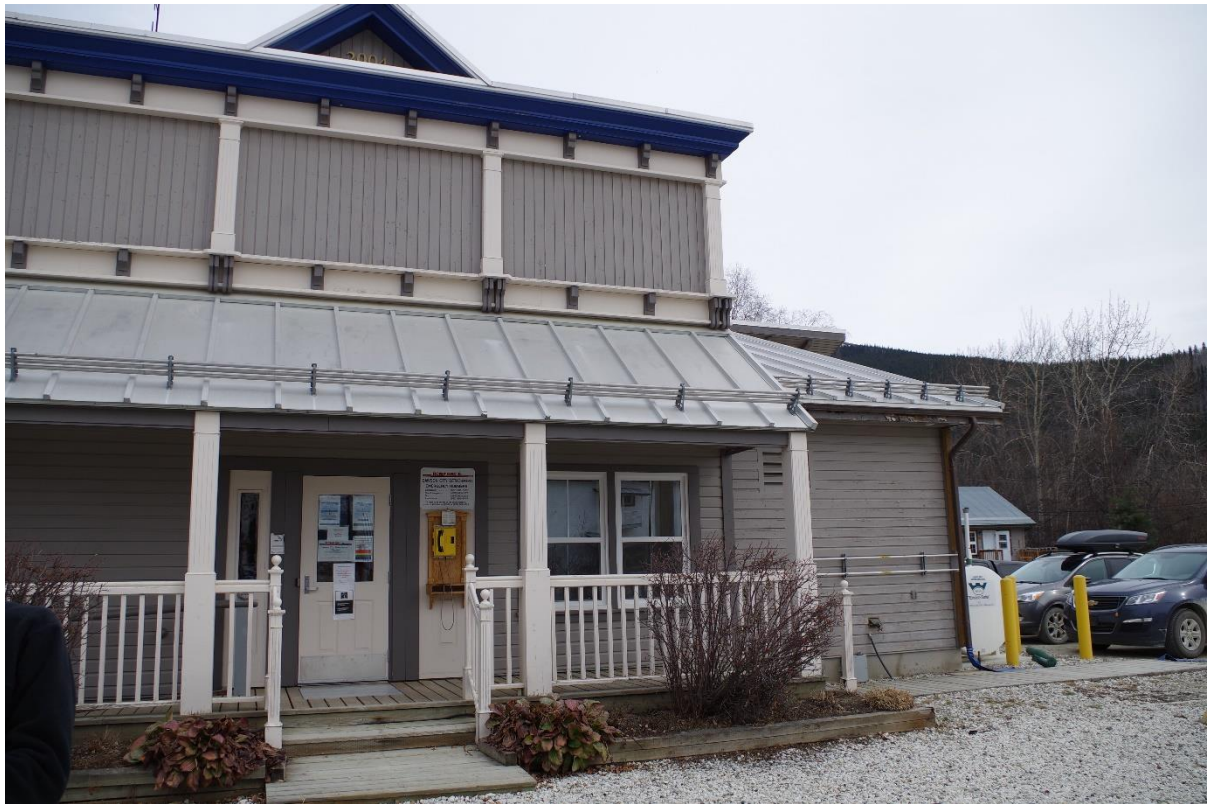
Community	Dawson
ID #	39
Asset	RCMP Main building (offices)
Location	Turner St. and Front St.

Surveyed feature	First floor / Doorstep			
Elevation	319.6 m	Flood return period	Open storm drains	65 years
			Closed storm drains	120 years
			Optimal dike	200 years
		Annual flood probability	Open storm drains	1.5%
	Closed storm drains		0.8%	
	Optimal dike		0.5%

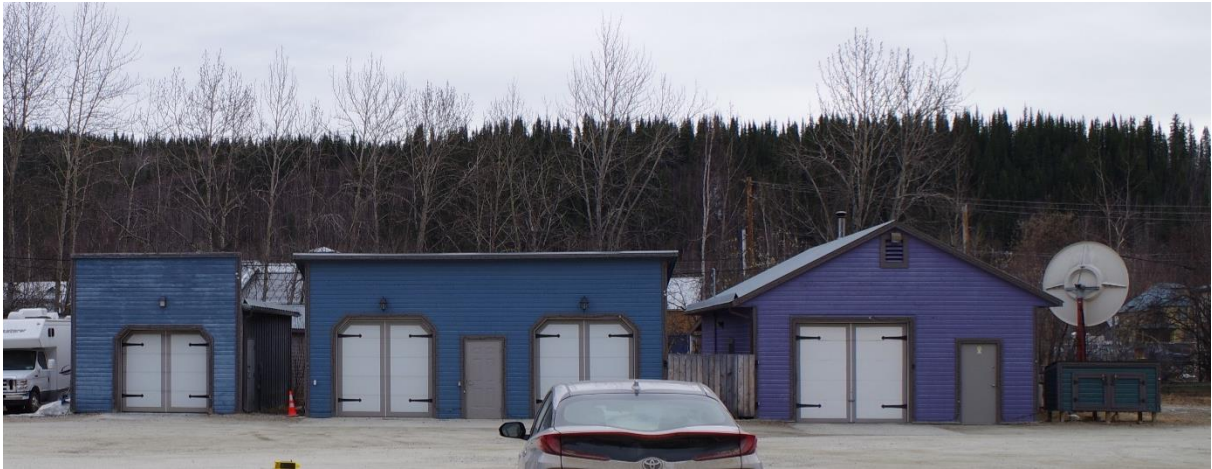
Community	Dawson			
ID #	40-41-42			
Asset	RCMP Main building (offices)			
Location	Turner St. and Front St.

Surveyed feature	Concrete slab / Doorstep (four doors from South to North)			
Elevation	318.6 m to 318.8 m	Flood return period	Open storm drains	15-20 years
			Closed storm drains	120 years
			Optimal dike	200 years
		Annual flood probability	Open storm drains	6%-7%
			Closed storm drains	0.8%
			Optimal dike	0.5%

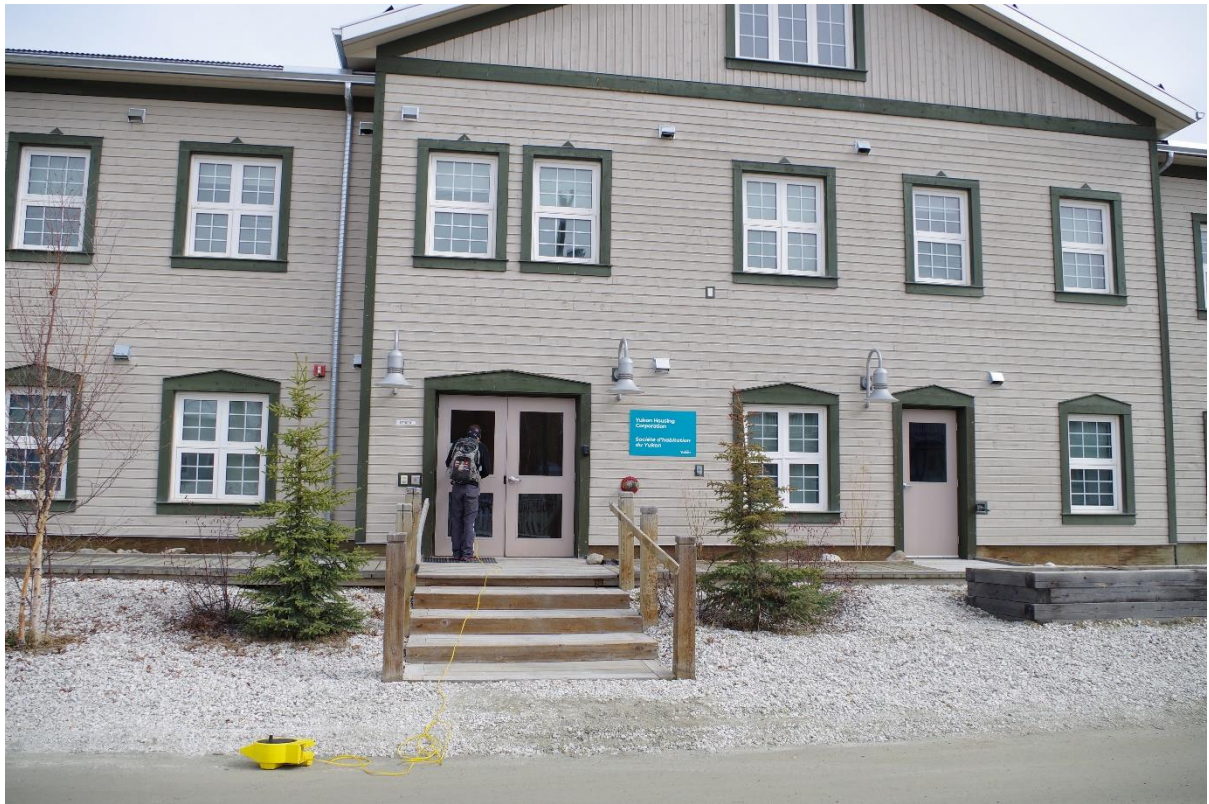
Community	Dawson
ID #	43
Asset	Yukon Housing
Location	Turner St. and 5 <sup>th</sup> Ave.

Surveyed feature	First floor / Doorstep / Wood boardwalk			
Elevation	319.7 m	Flood return period	Open storm drains	75 years
			Closed storm drains	120 years
			Optimal dike	200 years
		Annual flood probability	Open storm drains	1.3%
Closed storm drains	0.8%			
Optimal dike	0.5%

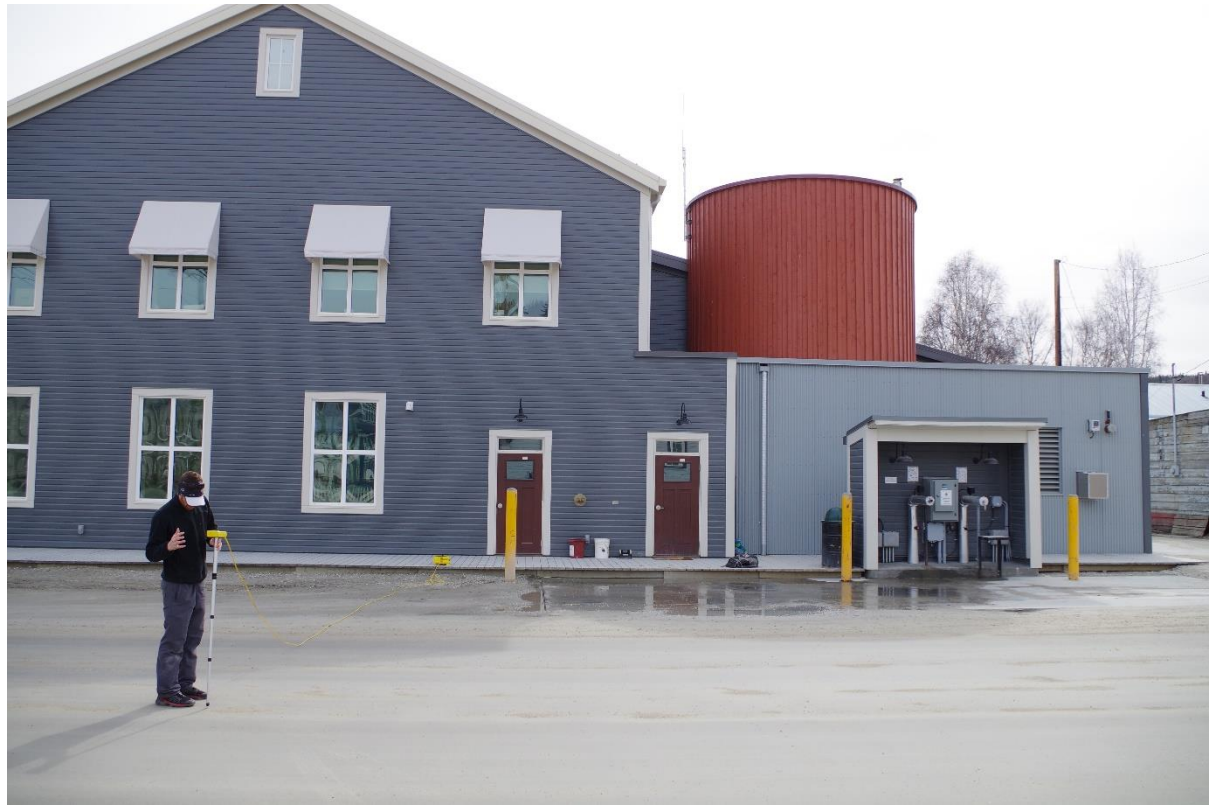
Community	Dawson
ID #	44
Asset	Water Station
Location	Turner St. and 5 <sup>th</sup> Ave.

Surveyed feature	First floor / Doorstep / Wood boardwalk			
Elevation	319.3 m	Flood return period	Open storm drains	45 years
			Closed storm drains	120 years
			Optimal dike	200 years
		Annual flood probability	Open storm drains	2.2%
			Closed storm drains	0.8%
			Optimal dike	0.5%

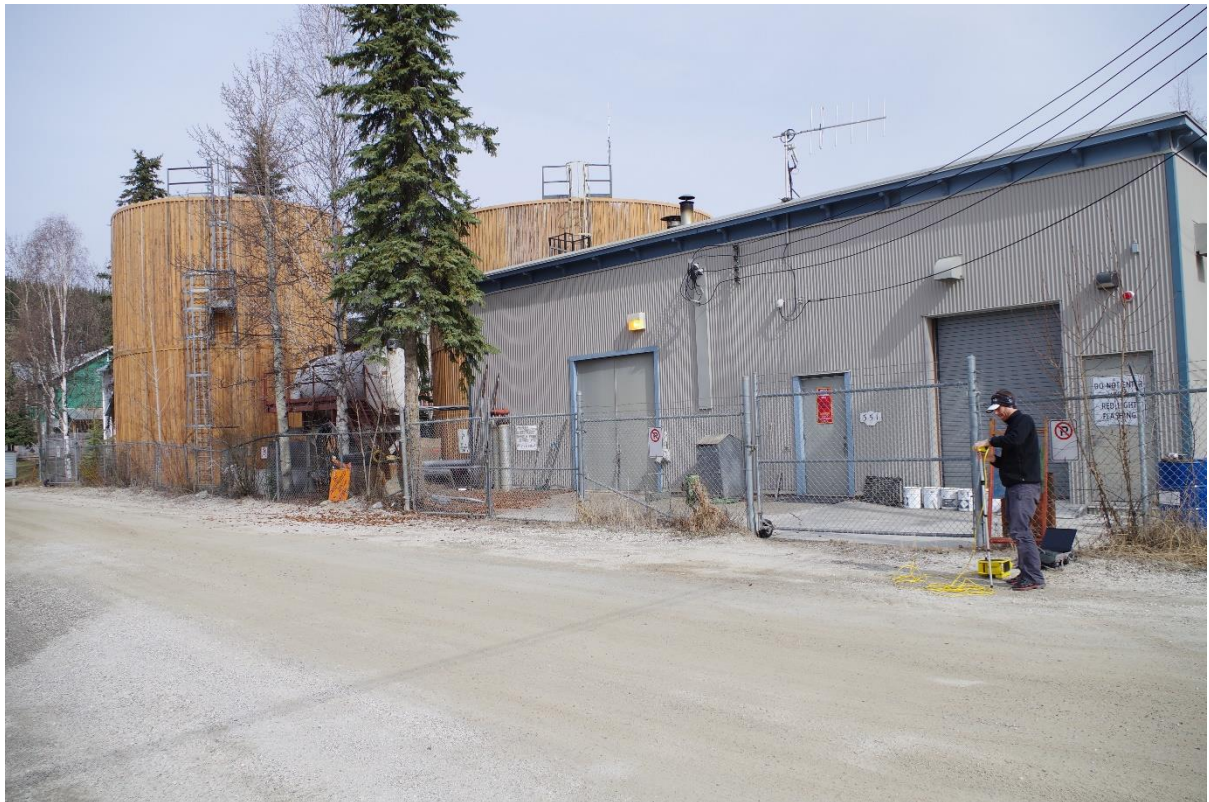
Community	Dawson
ID #	45
Asset	Water-related building
Location	Dugas St. and 5 <sup>th</sup> Ave.

Surveyed feature	First floor / Concrete slab (approximate because no access)				
Elevation	319.5 m	Flood return period	Open storm drains	55 years	
			Annual flood probability	Closed storm drains	120 years
				Optimal dike	200 years
		Open storm drains		1.8%	
			Closed storm drains	0.8%	
			Optimal dike	0.5%

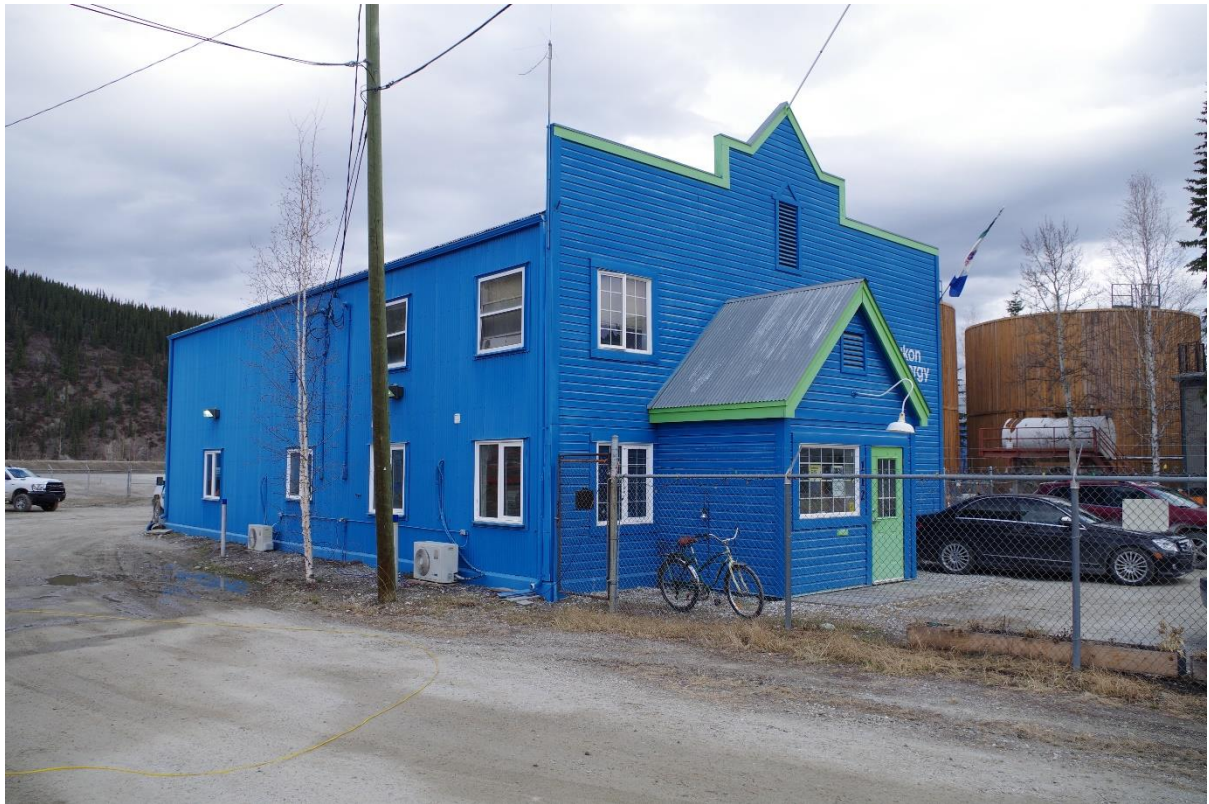
Community	Dawson
ID #	50
Asset	Yukon Energy Corporation (YEC) main office building (Blue)
Location	5 <sup>th</sup> Ave. between Dugas St. and Front St.

Surveyed feature	First floor / Doorstep			
Elevation	319.4 m	Flood return period	Open storm drains	50 years
			Closed storm drains	120 years
			Optimal dike	200 years
		Annual flood probability	Open storm drains	2%
	Closed storm drains		0.8%	
	Optimal dike		0.5%

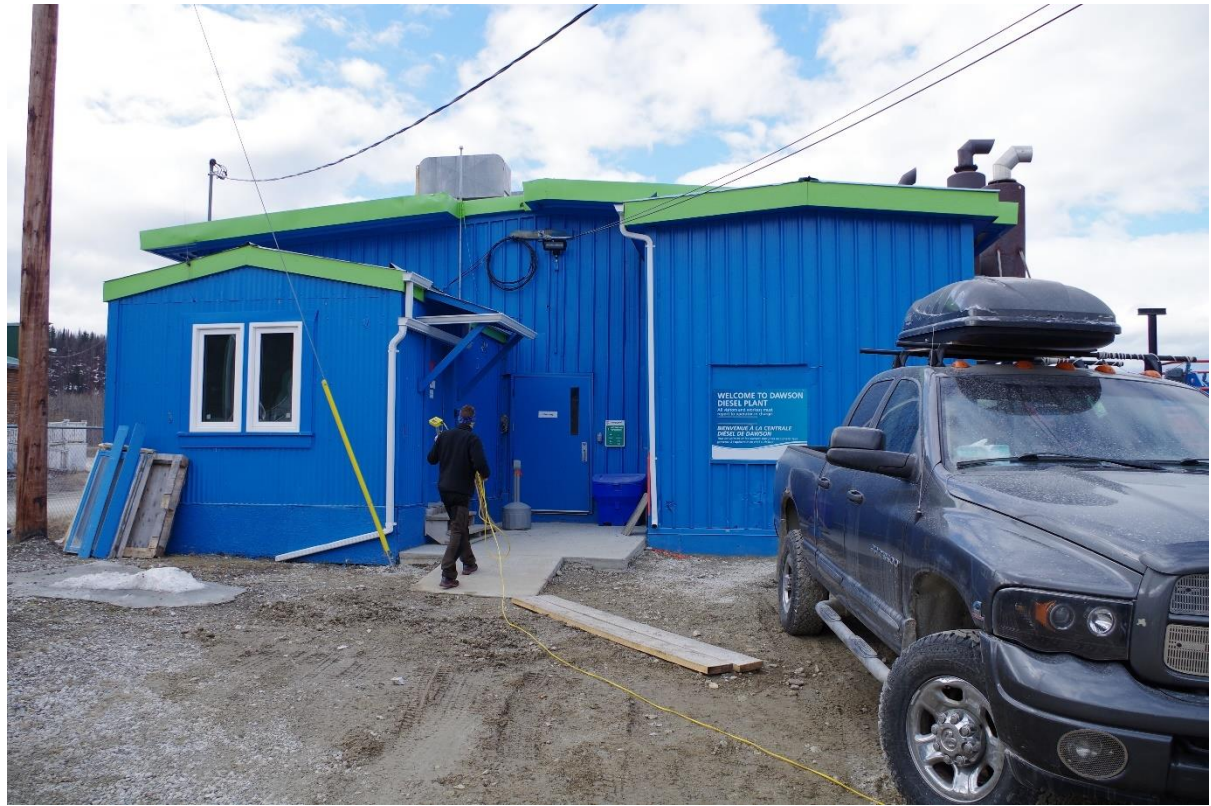
Community	Dawson
ID #	51
Asset	Yukon Energy Corporation (YEC) Diesel Plant (Blue)
Location	5 <sup>th</sup> Ave. between Dugas St. and Front St.

Surveyed feature	First floor / Doorstep			
Elevation	320.4 m	Flood return period	Open storm drains	190 years
			Closed storm drains	190 years
			Optimal dike	200 years
		Annual flood probability	Open storm drains	0.5%
Closed storm drains	0.5%			
Optimal dike	0.5%
