# Flooding in Dawson: Exposure analysis and risk reduction recommendations

March | 2022

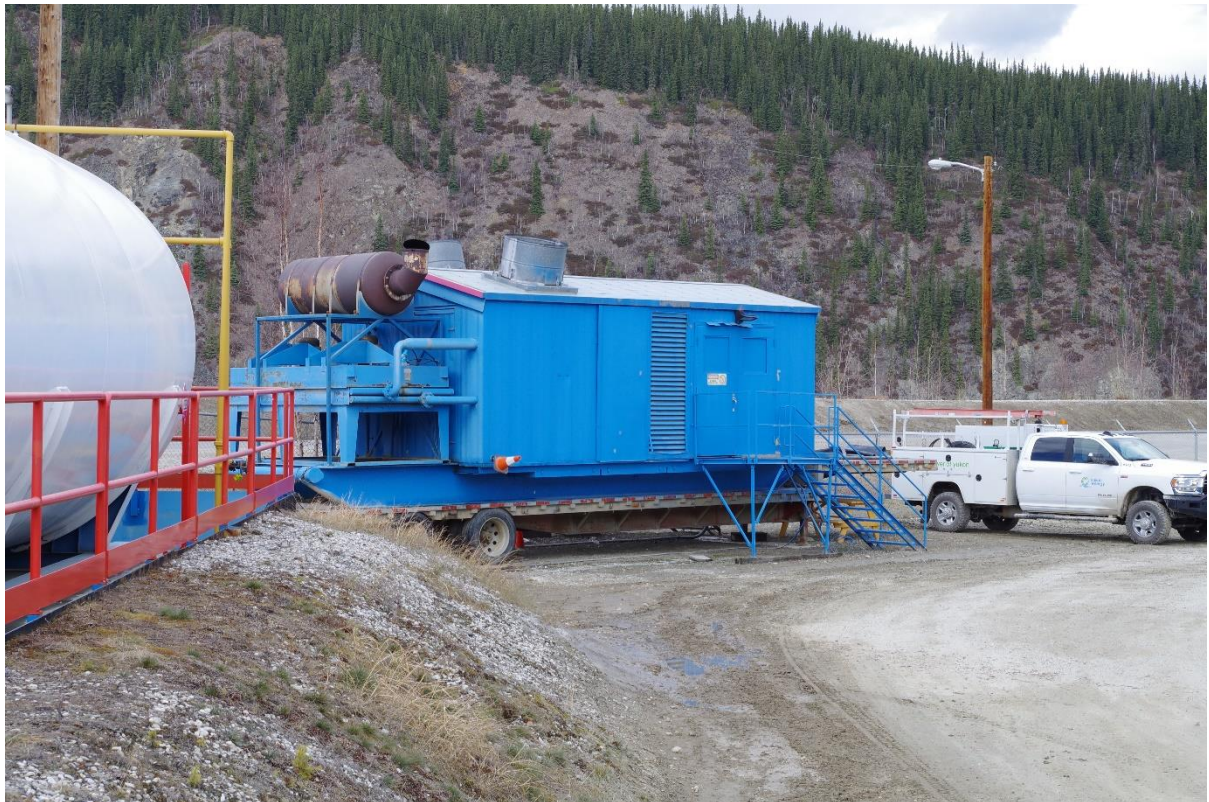
Community	Dawson
ID #	52
Asset	Yukon Energy Corporation (YEC) Diesel Turbine on trailer (Blue)
Location	5 <sup>th</sup> Ave. between Dugas St. and Front St.

Surveyed feature	First floor / Top of stairs			
Elevation	320.7 m	Flood return period	Open storm drains	210 years
			Closed storm drains	210 years
			Optimal dike	210 years
		Annual flood probability	Open storm drains	0.5%
			Closed storm drains	0.5%
			Optimal dike	0.5%

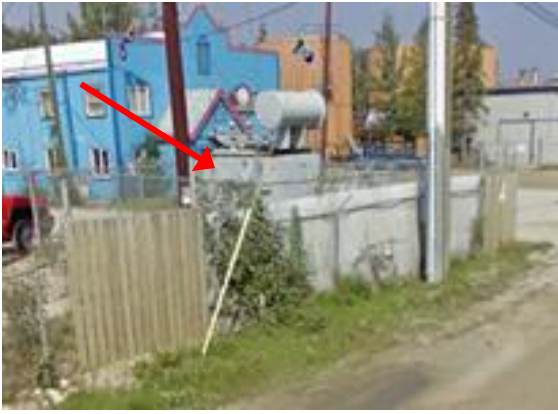
Community	Dawson			
ID #	53			
Asset	Yukon Energy Corporation (YEC) Transformer (fenced)			
Location	5 <sup>th</sup> Ave. between Dugas St. and Front St.

Surveyed feature	Concrete slab / Ground level			
Elevation	320.1 m	Flood return period	Open storm drains	130 years
Note: Photo from Google Street View.			Closed storm drains	145 years
			Optimal dike	200 years
		Annual flood probability	Open storm drains	0.8%
Closed storm drains	0.7%			
Optimal dike	0.5%

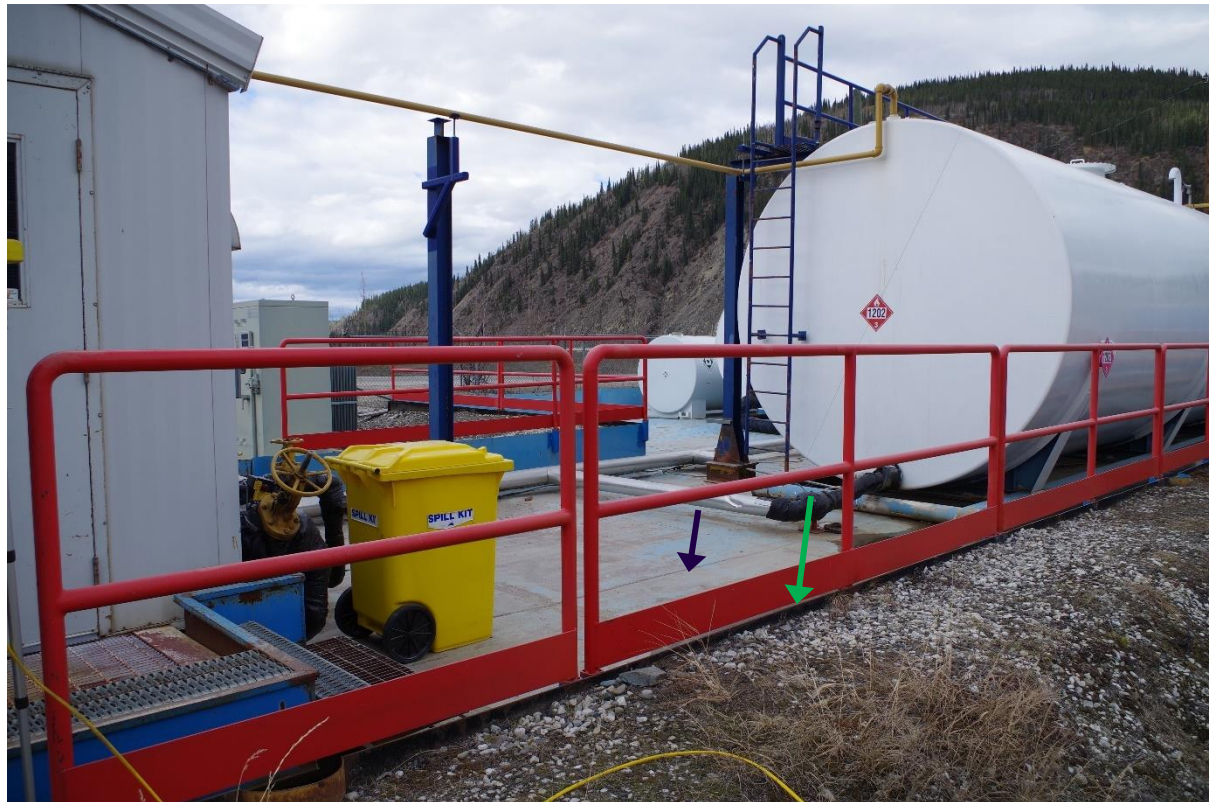
Community	Dawson
ID #	54-55
Asset	Yukon Energy Corporation (YEC) metal dike (and metal slab for fuel tanks)
Location	5 <sup>th</sup> Ave. between Dugas St. and Front St.

Surveyed feature	Metal dike surface / Green arrow (Metal floor surface / black arrow)			
Elevation	320.6 m (320.0 m)	Flood return period	Open storm drains	200 years (115 years)
			Closed storm drains	200 years (130 years)
Optimal dike	200 years			
Annual flood probability		Annual flood probability	Open storm drains	0.5 % (0.9%)
			Closed storm drains	0.5% (0.8%)
			Optimal dike	0.5%

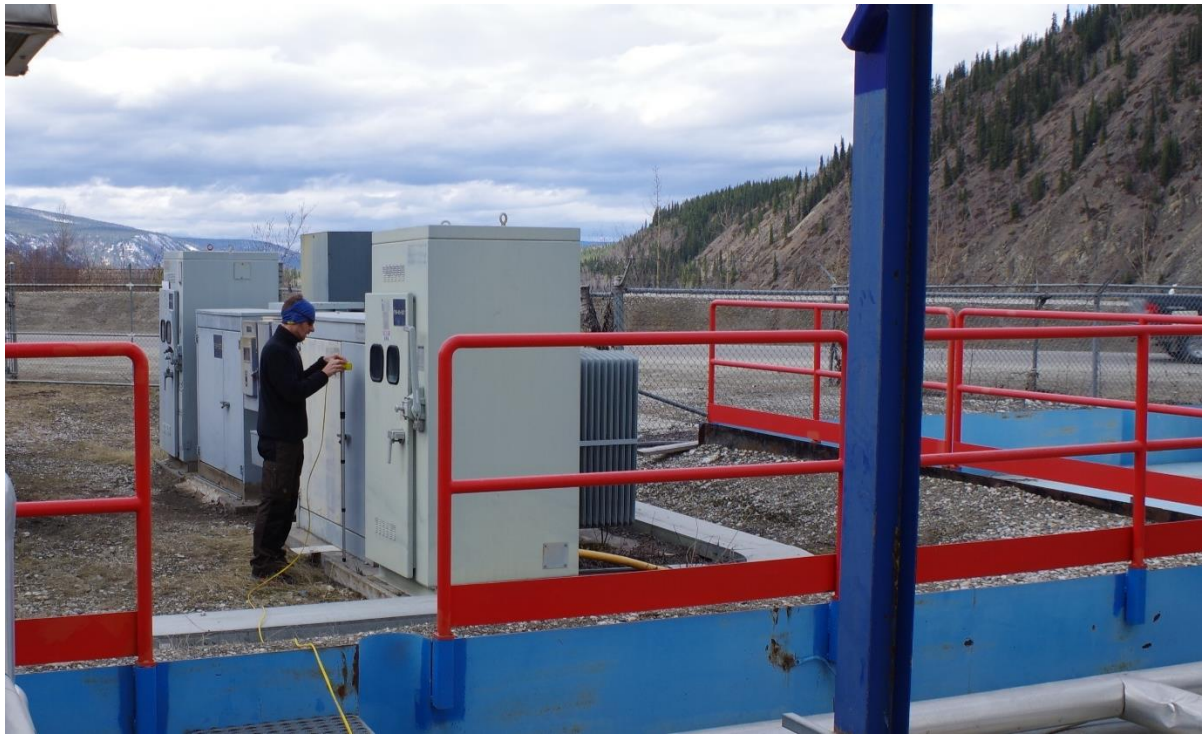
Community	Dawson
ID #	56
Asset	Yukon Energy Corporation (YEC) electric boxes
Location	5 <sup>th</sup> Ave. between Dugas St. and Front St.

Surveyed feature	Concrete slab / Footing			
Elevation	320.2 m	Flood return period	Open storm drains	150 years
			Closed storm drains	160 years
			Optimal dike	200 years
		Annual flood probability	Open storm drains	0.7%
			Closed storm drains	0.6%
			Optimal dike	0.5%

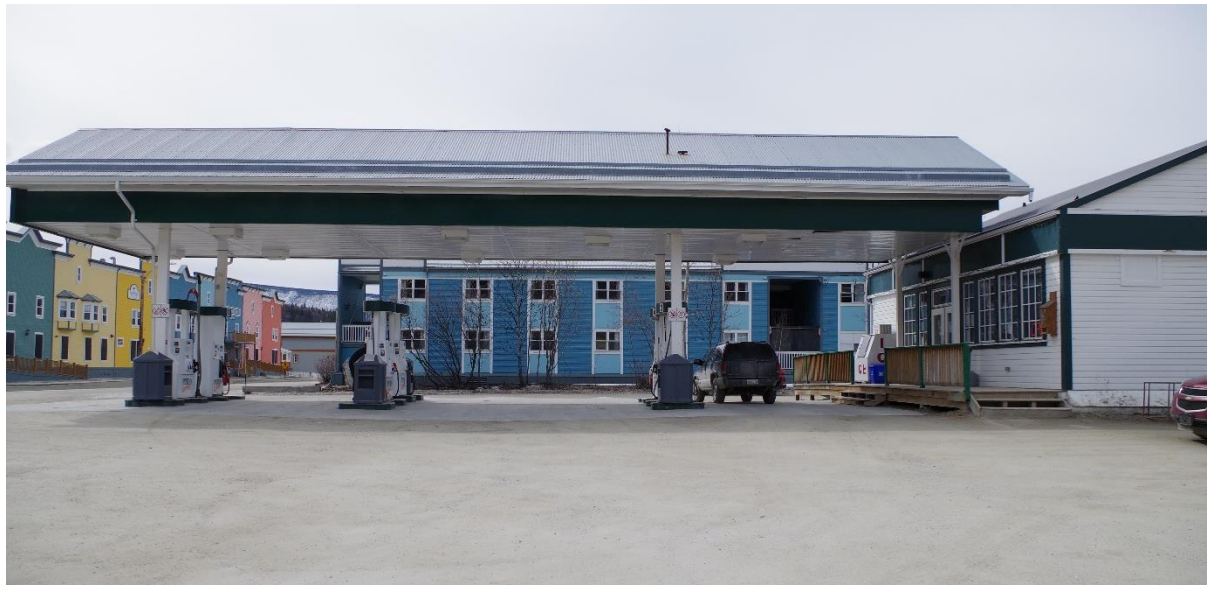
Community	Dawson			
ID #	57			
Asset	North of 60 Petro gas station			
Location	5 <sup>th</sup> Ave. and Princess St.

Surveyed feature	Lowest visible underground reservoir valve (ground surface)			
Elevation	319.5 m	Flood return period	Open storm drains	60 years
			Closed storm drains	120 years
			Optimal dike	200 years
		Annual flood probability	Open storm drains	1.7%
			Closed storm drains	0.8%
			Optimal dike	0.5%

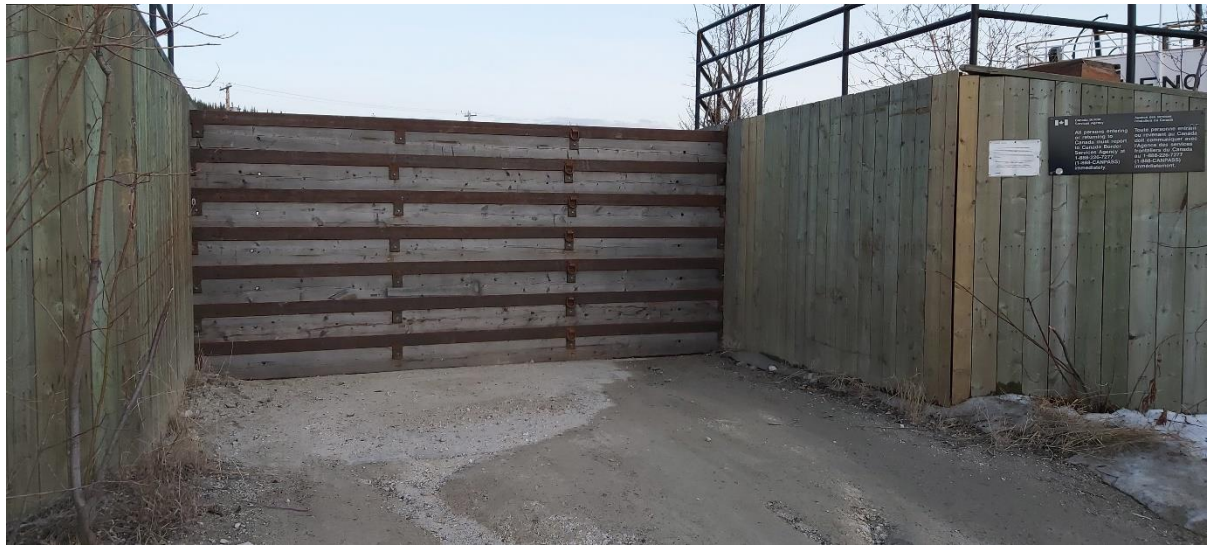
Community	Dawson			
ID #	58			
Asset	Gate in dike			
Location	Dike / North of Keno

Surveyed feature	Ground level / Concrete slab			
Elevation	318.9 m	Flood return period	Open storm drains	20 years
Note: This gate must be closed prior to a dynamic river ice breakup event.			Closed storm drains	120 years
			Optimal dike	200 years
		Annual flood probability	Open storm drains	5%
Closed storm drains	0.8%			
Optimal dike	0.5%

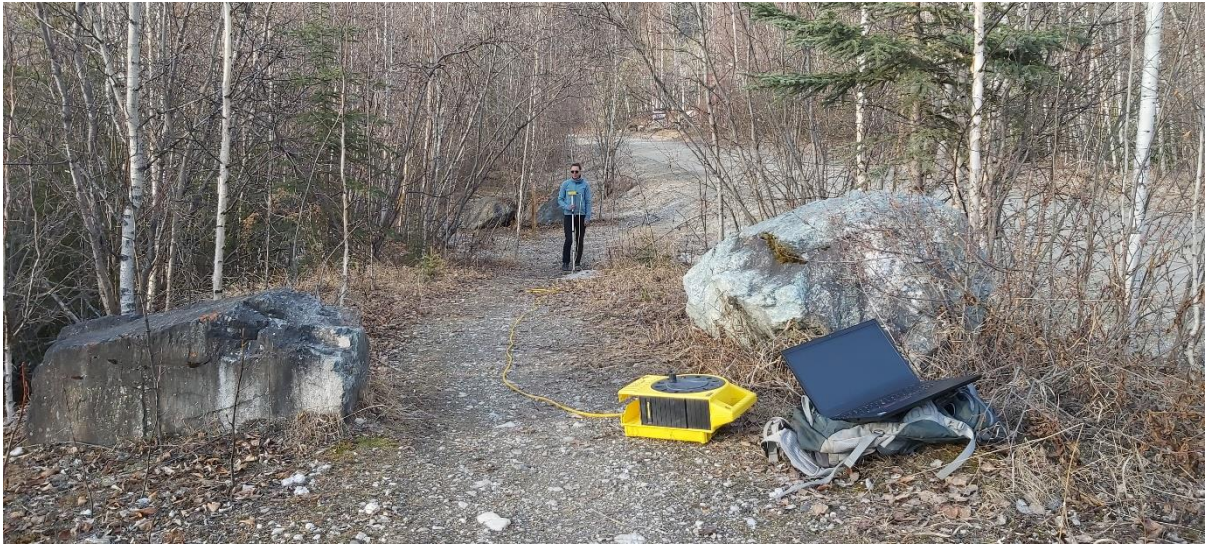
Community	Dawson			
ID #	59			
Asset	Dip at the North end of dike			
Location	North end of front street on the left

For a 200-year event simulation, it is obvious that water could enter town over the dike on several low points at the downstream end of town. This represents the dominant flooding factor over the status of the storm drain valves and manhole elevations. The water surface elevation at the location where water would flow over the dike (middle of the 4 low points identified in Figure 4.1.1) is 320.6 m. For the simulation, upstream and downstream areas in town were filled up to this level, assuming that the flood event would last long-enough to reach an equilibrium hydraulic condition, with largely stagnant water in Dawson (like in 1979).

Surveyed feature	Lowest point, center of dike			
Elevation	319.9 m	Flood return period	Open storm drains	120 years
Note: This is the reason why most assets in Dawson are protected against a 120-year event rather than a 200-year event.			Closed storm drains	120 years
			Optimal dike	200 years
		Annual flood probability	Open storm drains	0.9%
Closed storm drains	0.9%			
Optimal dike	0.5%
